## EXTENSION OF CONTAINER LIFE THROUGH LOW-COST PROBABILISTIC ASSESSMENT

**Tim Gleed-Owen**  
**(Senior Engineer, RAM Containers)**  
Rolls-Royce Power Engineering Plc, PO Box 2000,  
Derby, DE21 7XX, Great Britain

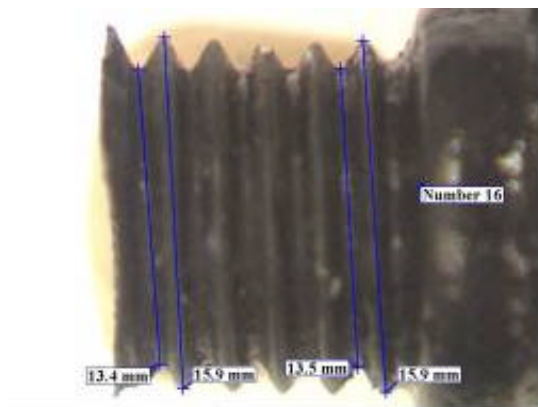
**Figure 2 Typical Replica from Worn Flange Thread**

Of these 1,300-plus locations on Set B containers, a small group of 32 were selected at random for detailed quantification of the wear problem. Although these locations were selected without prior knowledge of their condition in order to maintain an unbiased approach, it was ensured that the batch represented all of the generic locations on the design. This included flange corners, short edges, long edges adjacent to bulkheads, and other positions remote from any local stiffeners. The batch was also taken across a group of eight different containers selected at random, to avoid any bias to the results arising from a container-specific issue, such as material batch, or bias in tolerances at the time of manufacture. These 32 thread positions were replicated with Microset Replication Putty. A typical replica is shown on Figure 2.

Random sampling was again taken for Sets A & C. The same criteria were adopted in selecting positions for replication, and amounted to 29 (Set A) and 30 (Set C) samples from ten different containers. Inspection of the replicas was undertaken with a 3-axis digital viewer with macro lens and camera, and 'a4i Docu Image' measurement software, to inspect profiles of the thread flanks, roots and crests, to quantify the major and minor diameters, and record the images with measurements. Again, the orientation of each specimen on the viewer was taken at random, recognizing the possibility of variability occurring around the perimeter of each thread. A typical replica with measurements is shown on Figure 2.

Inspection of the replicas indicated a general loss of material from the thread forms of the nuts, characterised both by receding of the crests, and narrowing of the thread included angle. In addition, the roots were very broad and ill-defined. Artificially worn test nuts, created by consolidated hand-tapping, exhibited very similar characteristics. The adoption of aggressive container maintenance procedures in the use of thread-cutting taps to clean holes, was clearly contributory. A further factor is believed to be weld distortion at build and overhaul maintenance, requiring many holes to be opened up with a tap prior to service.

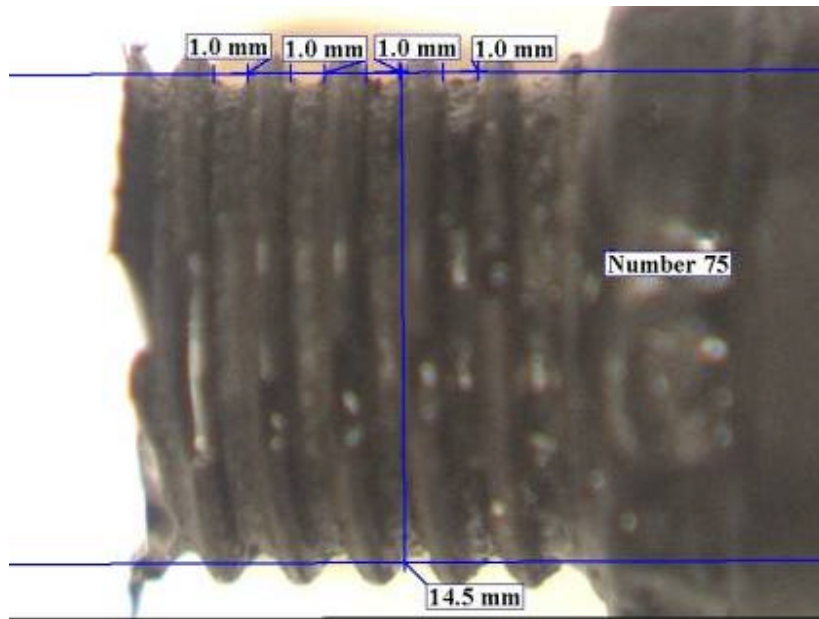
**Figure 3 Thread Shear Area Measurement**

each nut putty replica was assessed at the design nominal effective diameter (14.5 mm from BS 1580), to measure the mean shear thickness of the residual female threads. This technique was chosen as being more relevant to strength of the irregular thread forms than measures of major and minor diameter. These measurements are shown on a sample in Figure 3. This shear thickness, developed around the theoretical surface of the effective diameter, over the number of threads engaged (typically six), gave a measure of the female thread shear area. Accordingly, this was an indicator of shear strength, that could be plotted against failure load and assessed for trends.

Assessment of the failure load results against this shear area, together with a quantification of the damage on the containers, would form the basis of the safety case.

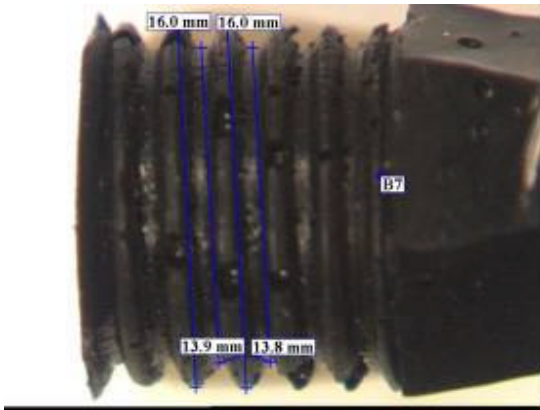
**Figure 4 Test Nut Replica with Minor Wear**

Thirty-eight of these nuts were deliberately abused by running a tap through them a large number of times by hand, to simulate the cumulative effect of many maintenance periods. Replication putties were taken at intervals to monitor the degree of damage, and when the damage was deemed to be comparable with, or worse than, the container replicas, these nuts, with a spectrum of degrees of thread “wear”, were forwarded to the test programme. A piece of steel plate with a clearance hole, to represent the container flange, was used in the test machine for giving support to these nuts. Figure 4 and Figure 5 show typical variations in the thread wear created.

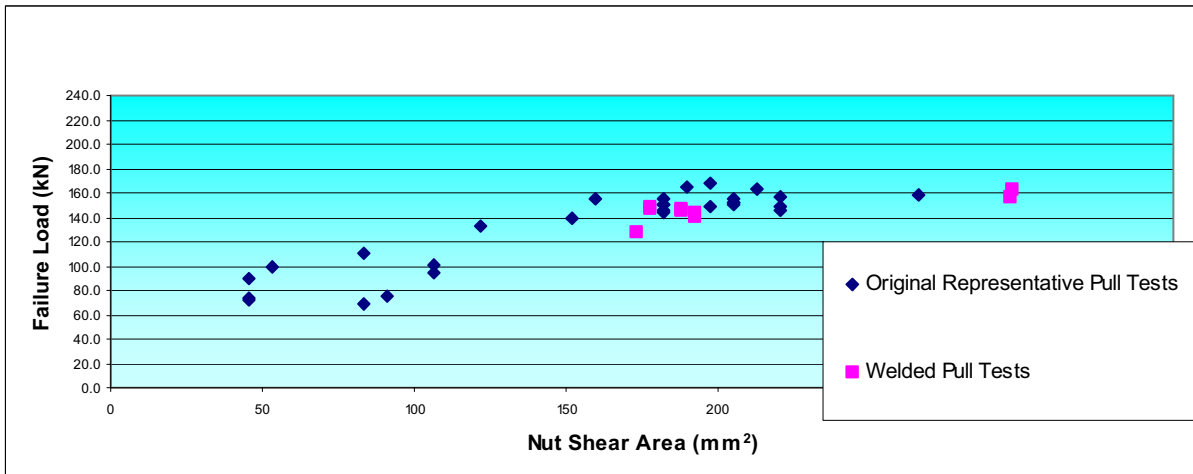
Figure 6 Test Data

The testing of each specimen to failure was conducted on a calibrated Denison tensile testing machine, using slow extension rates. All but six specimens failed by stripping of the worn nut threads. Those that failed by bolt tensile failure were generally those with the least amount of wear. All results are plotted on Figure 6. Included in this summary are the welded nut specimens, whose performance was not distinguishable from the whole population, as indicated by the pink data points on Figure 6.

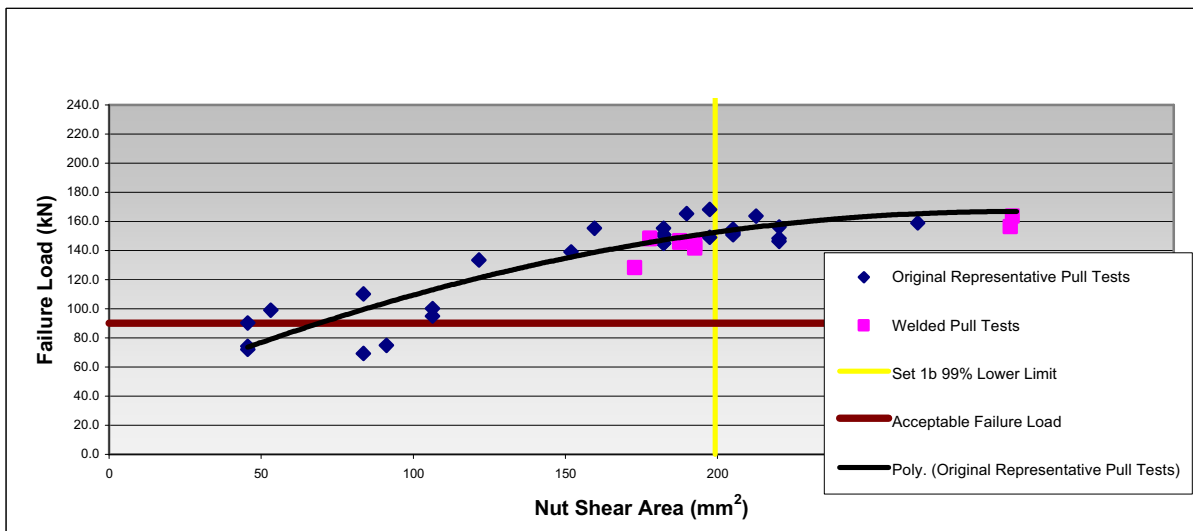
Figure 7 Results for Set A to 99% Confidence Level

Results of the container thread shear areas were analysed, first for statistical ‘normality’, and then for determining lower bound values to 99% confidence levels. Container Set A was shown to meet the criterion for a normal distribution by analysis of the 30 data points, and the lower bound shear area to 99% confidence level was 199.6 mm<sup>2</sup>, shown in yellow on Figure 7. The majority of the tested nuts fell below this shear area, and the failure loads in testing were generally above the pass criterion of 90 kN, as shown in Figure 7. The conclusion reached is that Set A is justified. To assess for absence of cliff-edge at 99.9% confidence level, a lower bound shear area of 186.1 mm<sup>2</sup> was calculated. This line, although not plotted on Figure 7, is shown on Figure 9 and clearly does not undermine the conclusion for Set A.

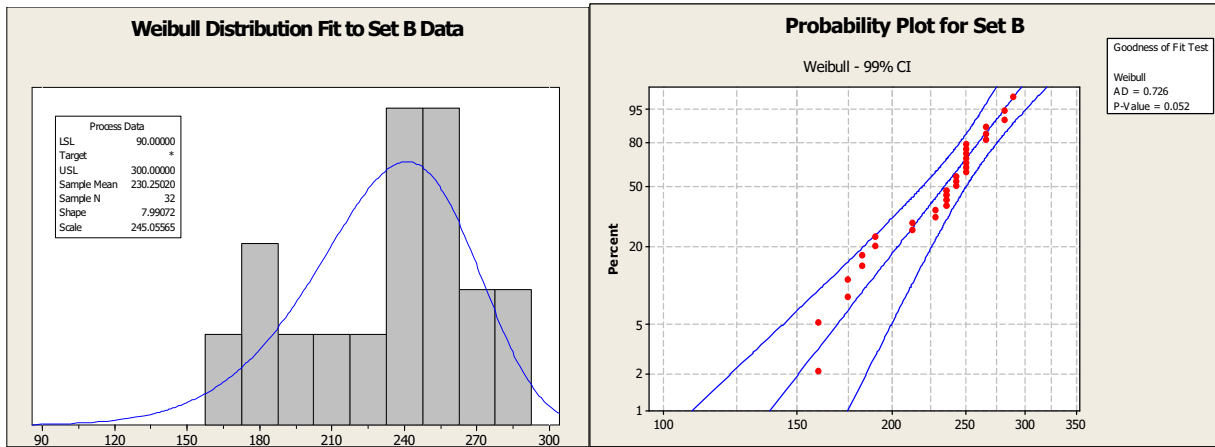
**Figure 8 Set B Weibull Distribution and Fitness Test**

Container Sets B and C had significantly skewed result sets, and failed against the Anderson-Darling criterion for ‘normality’. However, they were assessed against other types of distribution and found to comply with the criteria for a Weibull distribution. Of these two sets,

Set B was the worst in respect of general shear area, and as an example is shown as Figure 8 for the data and the fitness test.

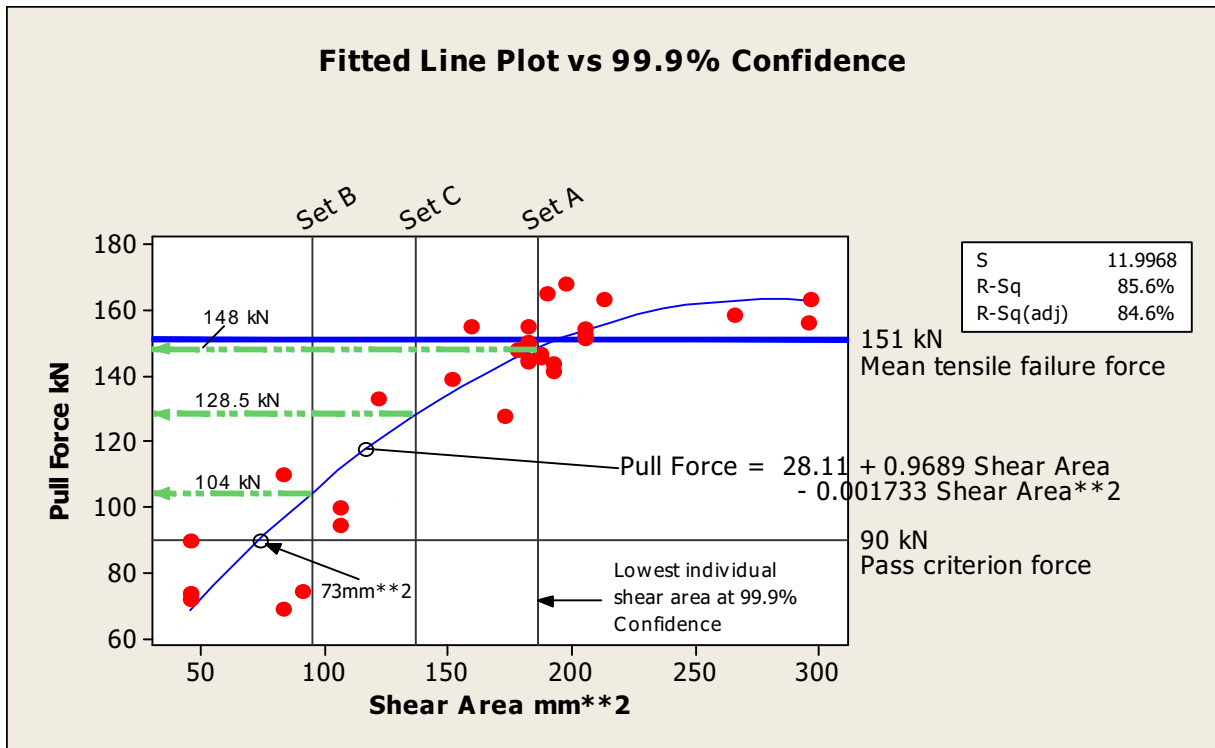
**Figure 9 Results to 99.9% Confidence Level**

Due to the pressing need for a justification for Sets B and C, only the second leg of the safety case was adopted, ie the absence of a cliff-edge at a 99.9% confidence level, as this would bound any result for the main approach to 99% confidence level. The lower-bound shear areas to 99.9% confidence level were 96.7 mm<sup>2</sup> for Set B and 146.9 mm<sup>2</sup> for Set C. The results are shown on Figure 9.

The test data is now separated into two groups, to better represent the mechanics of failure. Those bolts that failed in tension are represented by the horizontal blue line, set at the mean of the six relevant data points, being 151 kN. This line is horizontal because tensile failure of the

bolt is independent of nut shear area. All failures by stripping are represented by the best-fit polynomial line. These test results may be subject to some scatter, mainly caused by uncertainty of shear area resulting from a less than ideal resolution on the camera/software system used for measuring replicas. However, because this study is based on a conservative approach in the use of 99.9% confidence level data from the containers, the nominal test line shown by the blue polynomial in Figure 9 is deemed to be acceptable.

Container Set A is clearly justified on this probabilistic basis. The results for Sets B and C also show that, although the margins are reduced, there remains a significant margin between the worst-case nominal failure load of 104 kN and the pass criterion of 90 kN. All three container sets are justified for continued service, on the basis that integrity of the lid attachment is not undermined.
