Paper No.1036

Bolt Breakage Incident for Low-Level Radioactive Waste Container (1)

—Investigation into Cause and Measures—

Engineering Department, Nuclear Fuel Transport Co., Ltd., 1-1-3, Shiba Daimon, Minato-Ku,
Tokyo 105-0012, Japan

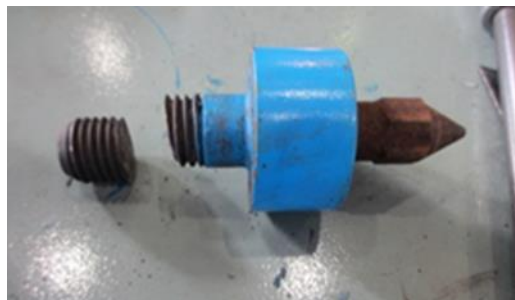
Photo 1 shows a fractured lid bolt. A delayed fracture occurs without any sign under specific conditions. Accordingly, if such conditions are satisfied, all kinds of bolts may experience delayed fractures. Here, NFT presents a warning about delayed fractures and information about prevention measures.

Photo 1 Fractured lid bolt

We examined the fracture surface of 16 broken lid bolts by the electron microscope. 15 lid bolts had an intergranular fracture that showed embrittlement.

Design and environment were specified as the causes of the breakages. For this reason, FTA was performed that was specific to the fracture mode of the lid bolts. As a result, the breakage was identified as due to delayed fracture (Table 2).

- Modification of lid bolt material

Tensile stress class 12.9 ⇒ 9.8

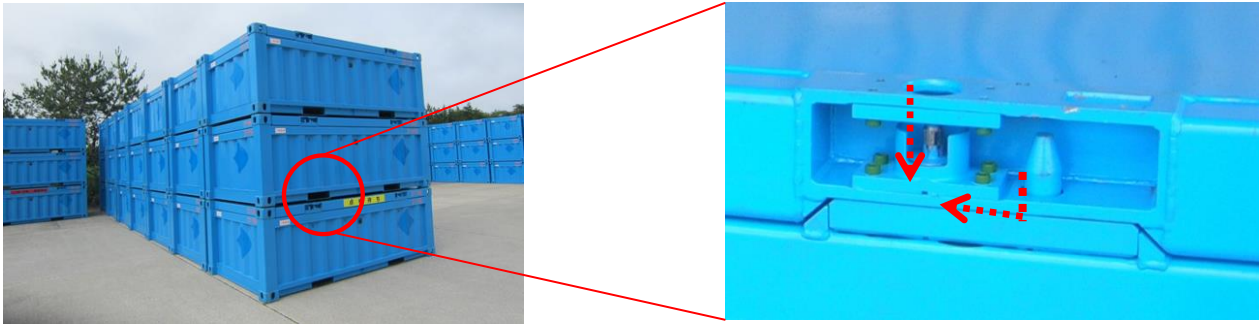
The following is an overview of the lid bolt structure and conditions during transport and storage. Under normal use conditions, an excessive load is not placed on the lid bolts. However, when stored outside, water (ex. rainwater) can easily enter a tightened lid bolt.

In the case of outdoor storage, lid bolts are directly exposed to wind and rain (Photo 2). The arrows indicate the water intrusion route to a lid bolt.

Photo 2 Transport containers stored outside at NFT LLW Center

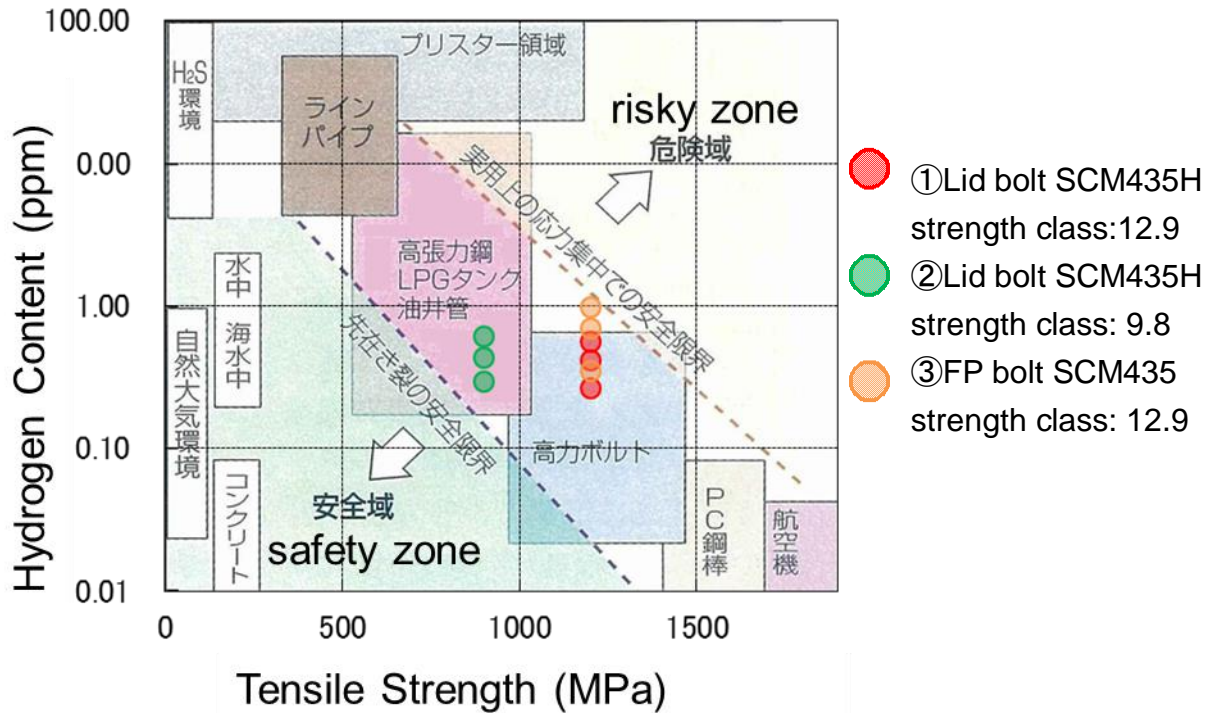
Delayed fracture is caused by a confluence of three elements (material strength, use environment and stress conditions). Accordingly, NFT measured the sensitivity to the amount of hydrogen in accordance with the strength class. From the results, we confirmed that the bolt breakage was caused by delayed fracture, and the effectiveness of the preventive measures (Fig.3). The strength class of the bolts was 12.9, which is close to the risky zone. Strength class 9.8 bolts are close to the safety zone and delayed fracture does not occur so easily. Therefore, it was concluded to be the adequate measure would be to lower the strength class of the material (12.9 ⇒ 9.8).

Fig.3 Plotted results of dissipative hydrogen content measurements (Plotted on references⁽³⁾)

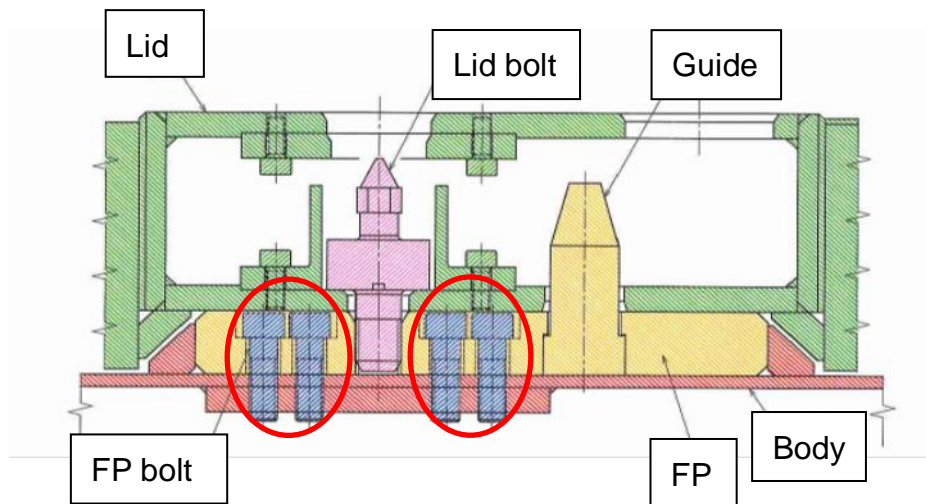
Fig 4 Overview of FP bolt

FP-bolt material tensile stress class: 12.9 ⇒ 9.8 (Fig 4)
