DEC 2017 CONTAMINATION INCIDENT AT THE IAEA SAFEGUARDS ANALYTICAL LABORATORY INVOLVING A SMALL QUANTITY OF NP-237

David Amaraggi, Markus Kohl, Mika Sumi, Steven Balsley, David Tissington, Diego Ortiz-Trujillo

International Atomic Energy Agency Laboratories, Friedensstrasse 1, A-2444 Seibersdorf, Austria

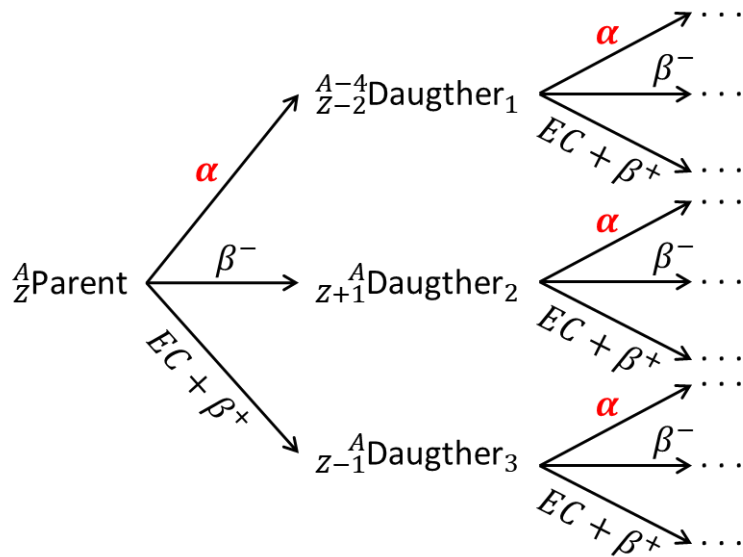
Figure 2: Energy deposited by alpha particles emitted by parents and the daughter nuclei taken into account in the estimation of the pressure build-up due to radiolysis

hydrogen and oxygen build up depends on both energy deposited in the solution by the emitted alpha particles and on the free volume above the solution (headspace). The energy released in the solution depends on the solution chemical characteristics (isotopic composition, total mass of radioisotope, molarity of nitric acid solution) and on the time elapsed since the production date. When the solution is stored in a gas-tight glass container, pressure build-up occurs. If not released, the container may rupture and result in an exothermic recombination of H₂ and O₂. Energetic release of radioactive liquid mixed with sharp glass fragments may cause serious injury, and result in internal and external contamination. This risk was well known by SGAS since the first incident that occurred in 2008 [2] and was followed up through monitoring of estimated pressure in glass-sealed containers with aqueous solutions containing alpha-emitting nuclides. A calculated pressure of two bar (0.2 MPa) was set as the action limit for the safe removal of an ampule from the inventory and its destruction using a specific device designed in 2008. In November 2015, the list of CRM in stock (about 1040 vials) was reviewed to identify potential safety hazards before physical transfer from the old SAL to the new NML. The pressure inside the ampules was estimated using an algorithm from previous works [3][4] and with available information in the corresponding certificates. Three glass-sealed ampules belonging to three different series were identified with a risk of bursting and were destroyed using the cracking device. Remaining CRM glass-sealed ampules were transferred with no incident to the NML and were stored with careful monitoring of the pressure build up. The inspection done on 11th December 2017 revealed that the headspace of the Np-237 containing vial was 20 time less than listed in the inventory database (1mL instead of 20 mL) leading to a significant under-estimation of the calculated pressure (7.8 bar instead of 1.3 bar). As the vial was being placed back into the aluminium can, the external force exerted on the vial by the staff member, together with the internal 7.8 bar pressure, probably caused the glass to crack. The movement of glass shards across micro fractures during the crack probably caused an electrical discharge that resulted in the energetic recombination of hydrogen and oxygen in the vial, and hence the flash that was reported.

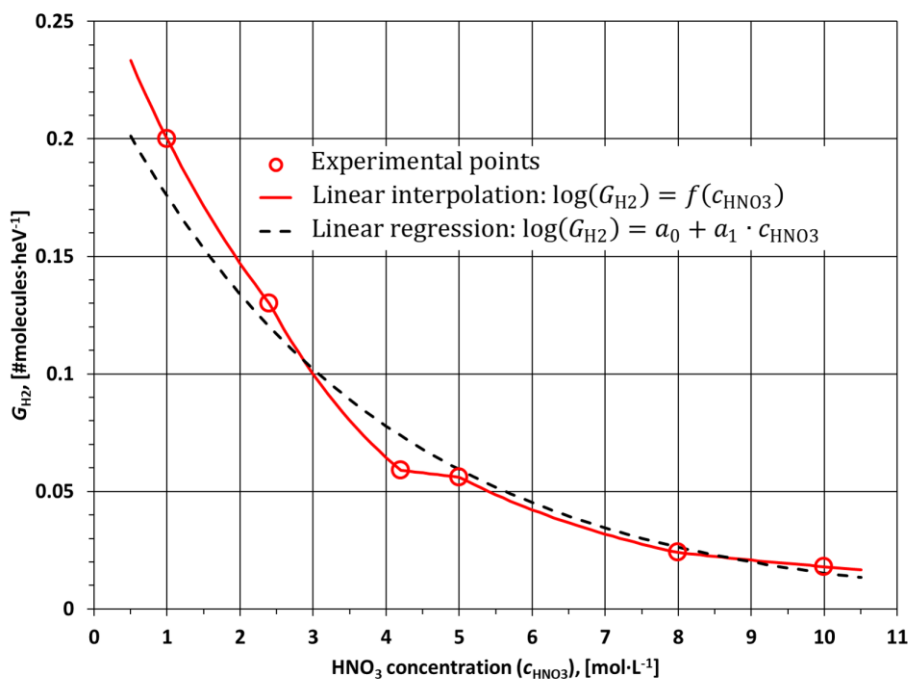
Graphic 1: Hydrogen yield as a function of molarity of nitric acid concentration\

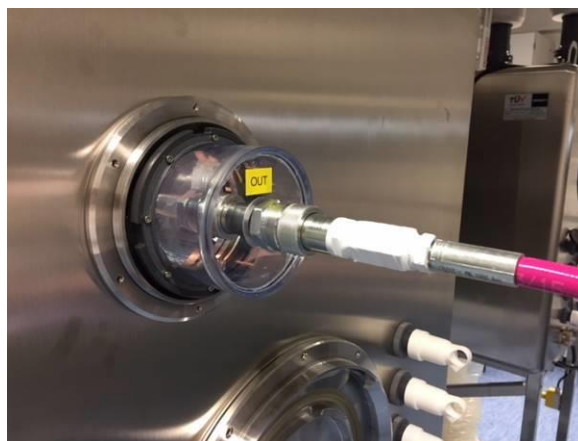
Figure 6: Feedthrough cover for hydraulic cable

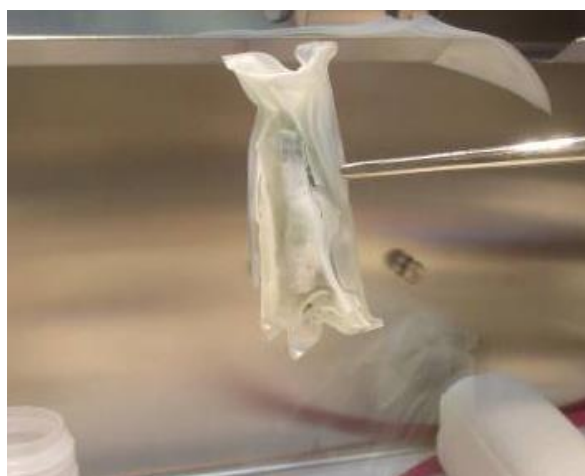
Figure 7: Frozen ampule

vials, 60mL) including cooling of ampule in liquid nitrogen and transfer to LiPo bag prior to crushing step (see figure 7).
