Title: Towards establishing a service life for the SAVY-4000 nuclear material storage container at Los Alamos National Laboratory

Intended for: INMM and ESARDA 2023 Joint Annual Meeting, 2023-05-22/2023-04-28 (Vienna, Austria)

Towards establishing a service life for the SAVY-4000 nuclear material storage container at Los Alamos National Laboratory

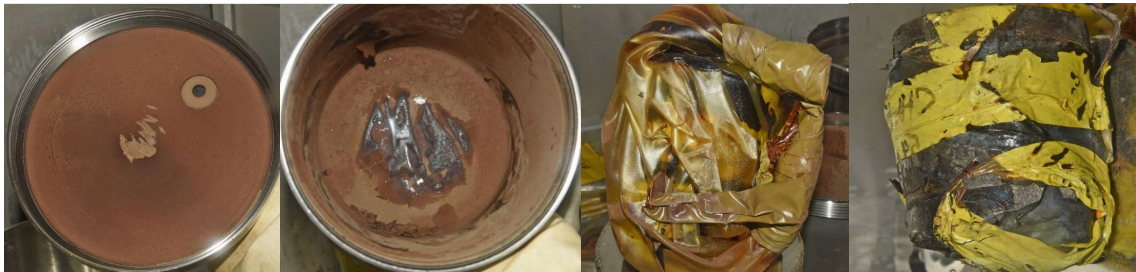
Figure 2. Heavily corroded Hagan container after 8.1 years. From left to right – the inside of the Hagan lid, the interior of the Hagan, the external second bag-out bag, the internal first bag-out bag.

Surveillance of Hagan and SAVY-4000 containers showed that both containers exhibited corrosion. The identified worst case for Hagan containers so far has been the “white powdered” Hagan discussed earlier. This molten salt extraction (MSE) residue was contained for 8.1 years in a Hagan and showed external signs of off-gassing in the form of a white powder observed near the filter and on the surfaces of the storage shelf. This white powder was analyzed and determined to be ammonium chloride [8]. The residue material was split to measure off-gassing utilizing an experiment designed from the Materials Identification and Surveillance (MIS) Working Group under the DOE Standard-3013 program. It was observed that off gassing of material only happens when enough water vapor is present to undergo radiolysis. Due to the presence of a filter on the

This Hagan container underwent corrosion analysis. Unfortunately, to unpack this item the container had to be introduced into the glovebox line and precluded typical surveillance testing. However, a sectioning saw was available and 3 representative samples were cut from the Hagan. These samples were cleaned in 2M nitric acid for 30 minutes, washed in DI water and dried. This cleaning method has shown to not remove base material or affect the shape of corroded pits within the subsurface. An optical microscope was used to observe the cleaned surface and pitting of the material. The worst pitting present was 40 μm deep and 105 μm in diameter. Assuming a linear growth rate, this results in a pit penetration rate of 5 μm per year. The nominal wall thickness of a Hagan container is 508 μm , meaning that only ~8% of the wall was penetrated over an 8-year period and through-wall pitting would occur in >100 years, assuming a linear growth model. More recent efforts have been initiated to establish more physically accurate pit growth models.

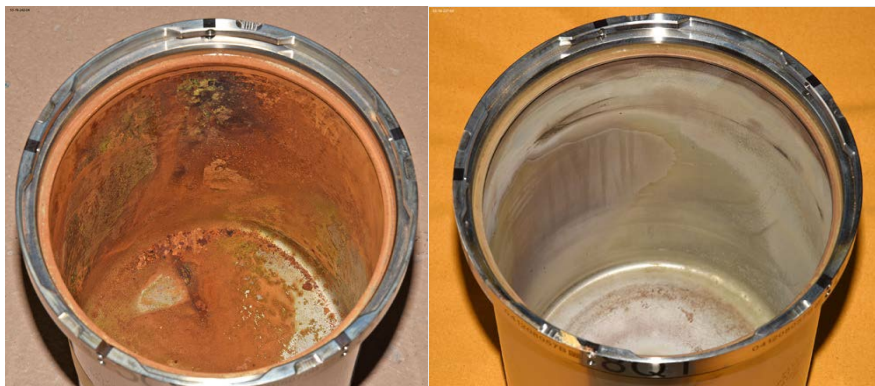
Figure 3. On the left, the SAVY-4000 that contained the SAI solution. This solution was in a plastic Erlenmeyer flask bagged out in polyethylene bag-out bag material. This solution was containerized for 14 months. On the right is the SAVY-4000 that contained “hatch” material

The worst cases of corrosion in SAVY-4000 containers were observed in solution assay instrument (SAI) calibration solutions (plutonium in 3M hydrochloric acid), MSE residue, and a “hatch” item. Hatch is high purity plutonium dioxide mixed with 7% Pu-238. The MSE residue, hatch and SAI items passed all surveillance testing. The SAI solution container showed large amounts of general corrosion, seen in [Figure 3](#). This corrosion product was easily wiped away with cleaning solution. The base surface showed that the laser-etched barcode and serial number were visible on the interior surface of the container. To evaluate whether the etching provides an area likely for corrosion, small samples of SAVY-4000 containers and Hagan containers underwent etching at different speeds, powers, and frequencies [9]. These samples were subjected to Iron (III) chloride to induce pitting in the samples. Based on the results, the etching did not play a role in pitting characteristics or rate.

After cleaning, the SAI solution container was removed from PF-4 and the wall thickness measured through a coordinate measuring machine and an ultrasonic wall thickness measurement device utilizing eddy current array flaw detection. These measurement devices did not detect any significant wall loss from the corrosion. This container was subsequently helium leak tested and

underwent design qualification drop testing 4 times. The container was loaded with 32.73 pounds of tungsten shot (total weight of 40.13 pounds) and was dropped in a center of gravity over bottom corner orientation from 12 feet 2 inches. After each drop the container underwent a helium leak test. The second drop orientation was center of gravity over top corner. The third drop utilized a side drop orientation, but a minor “slap down” occurred, meaning that the horizontal inclination of the container at impact was not 0° in reference to the impact plate. The fourth test was conducted in a similar side drop orientation, but on the other side of the container, 180° from the impact from the third drop test. This test also had a slap down impact, but slightly more aggressive than the third drop. The leak test after each of these drops passed; and in fact, the helium leak rate did not depend on the number of drops. This result also shows that the containment boundary was not compromised after 4 consecutive drops on a previously corroded container.

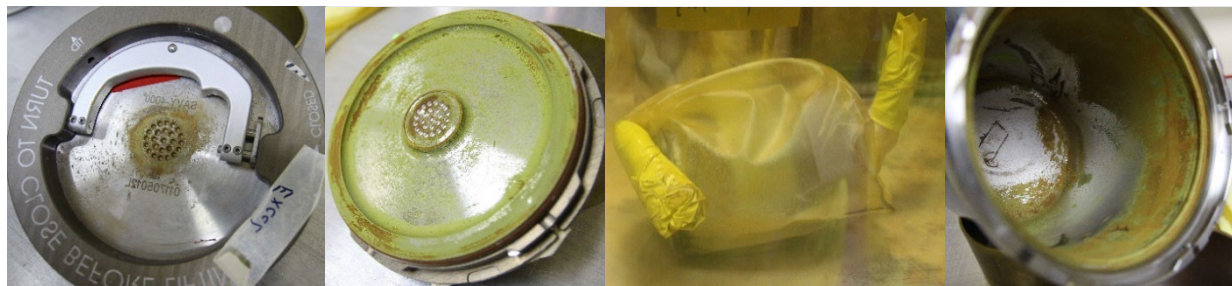
Figure 4. A SAVY-4000 discovered in a floor storage location during PF-4 walkdowns in late FY22. The external filter corrosion was identified and the material unpacked. From left to right – the external filter corrosion, the unpacked inner lid corrosion, the mostly pristine bag-out bag, and the inner body corrosion.

Annual surveillance will continue to occur providing data for both SAVY-4000 aging and Hagan aging. In FY22, a SAVY-4000 on a floor storage location was identified to have corrosion surrounding the filter as seen in [Figure 4](#). This item was unpacked, and the container passed all surveillance testing. This container has been removed from PF-4 for further study. The material within this container was a low wattage MSE residue. When unpacking, the bag-out bag material did not appear degraded. This suggests that the material itself was off gassing chloride gasses. The corrosion on the container was green, suggesting the formation of iron (II) chloride. This container has since turned rust colored, suggesting further oxidation after unpacking oxidized the container to iron (III) oxide. Additional studies of material off-gassing and the effect of relative humidity on gas generation and corrosion will also be conducted.
