## Trepanning Graphite Samples at a Shutdown Magnox Reactor: A US-UK Joint Exercise for Nuclear Verification

In April 2022, a team sponsored by the US DOE Office of Nuclear Verification (ONV) shipped trepanning equipment to the nuclear power station at Trawsfynydd, Wales, UK to collect samples from the graphite moderator of Reactor 1. The sampling campaign to collect 48 graphite samples was completed in five weeks beginning July 11. Half the samples will be analyzed in the US to determine the total energy production of the facility. The other half will be analyzed by Magnox Ltd. to support decisions for options for the ultimate decommissioning path for the facility.

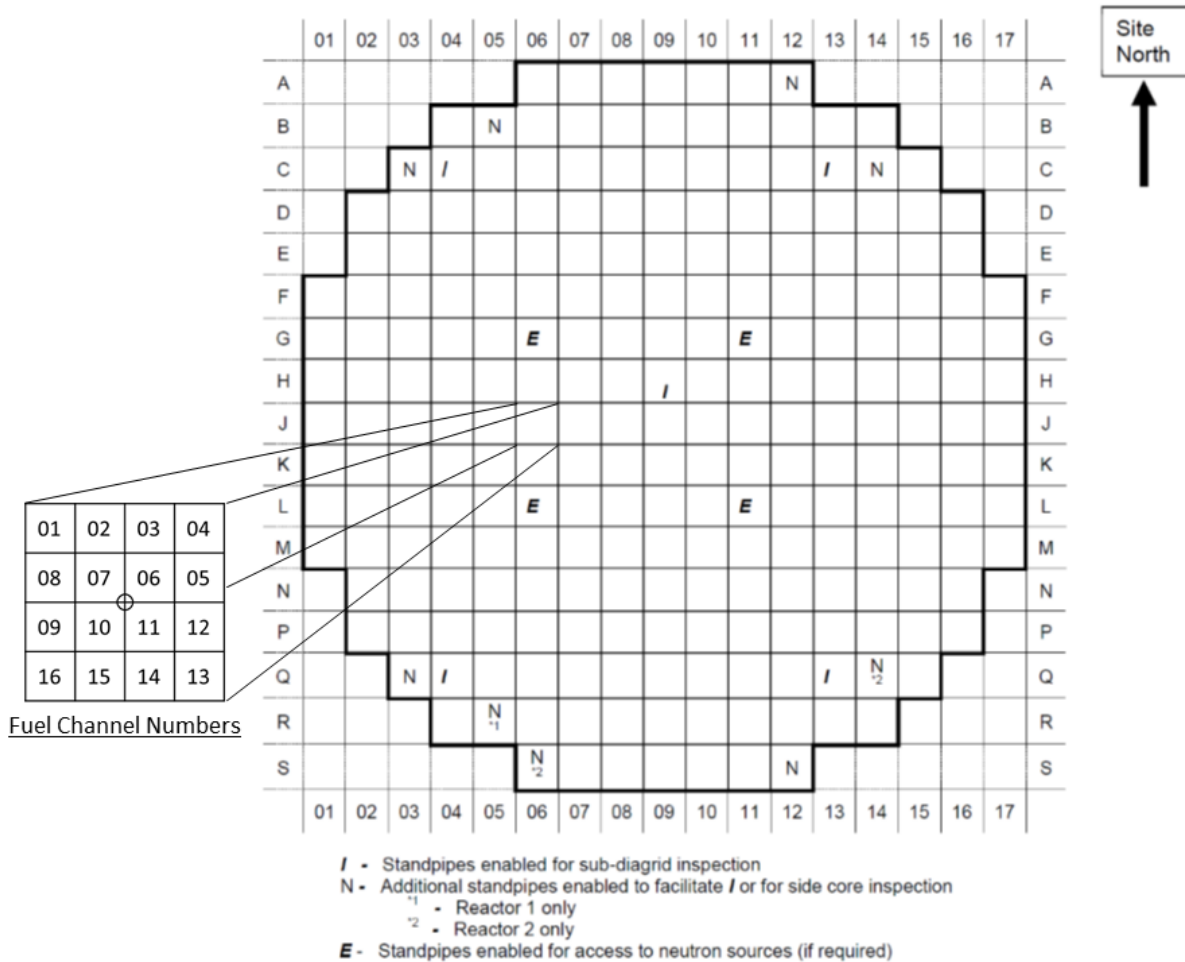
**Figure 1 – Standpipe numbering scheme. The standpipes used for sampling were: H09 (center), L06 (midpoint), and C03 and Q13 (core periphery)**

was made possible with the installation of reduced-height SCAs in 16 standpipes. The locations of the reduced-height SCAs are denoted with letters in Figure 1, which provides a plan view of the total 241 standpipes in the Reactor 1 core. Based on the time limits and projected sampling rate, four channels were selected for sampling, one located at the center, two on the periphery, and one midway between these.

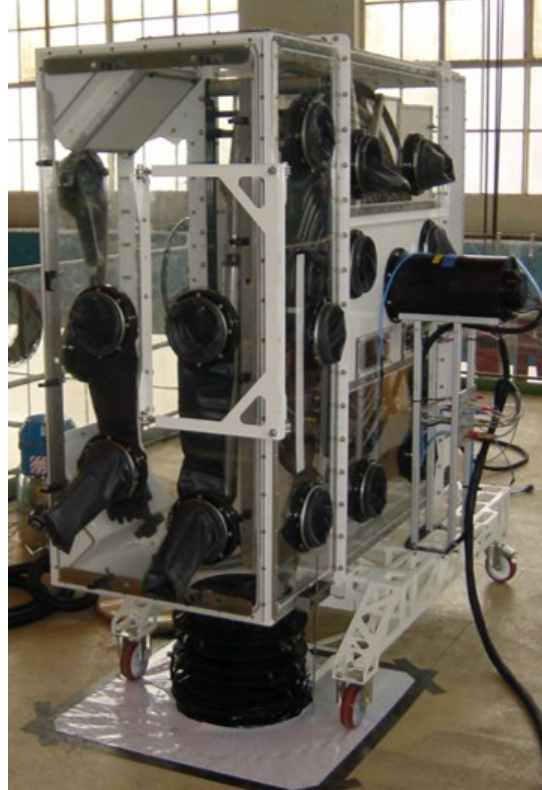
Figure 2. The trepanning tool in the movable containment positioned over a standpipe

The graphite sampling system consists of the sampling tool (or head) deployed into a reactor on an umbilical. The system is enclosed in a movable containment, shown in Figure 2, that limits the spread of contaminated graphite. Figure 3 shows a close-up view of the trepanning tool that is lowered into the standpipe and fuel channel on the umbilical for sample collection, while Figure 4 provides close-ups of the cutter (a) in the tool, (b) extended from the tool, and (c) in a Teflon storage pot. The diamond coated cutters were cleaned and stored under inert gas in these pots in 2019, to prevent corrosion until sampling, after which the cutters are returned to the pots for subsequent shipment for analysis. Each cutter has a tracking number engraved on the drive shaft, which is recorded during sampling along with the vertical position in the fuel channel.

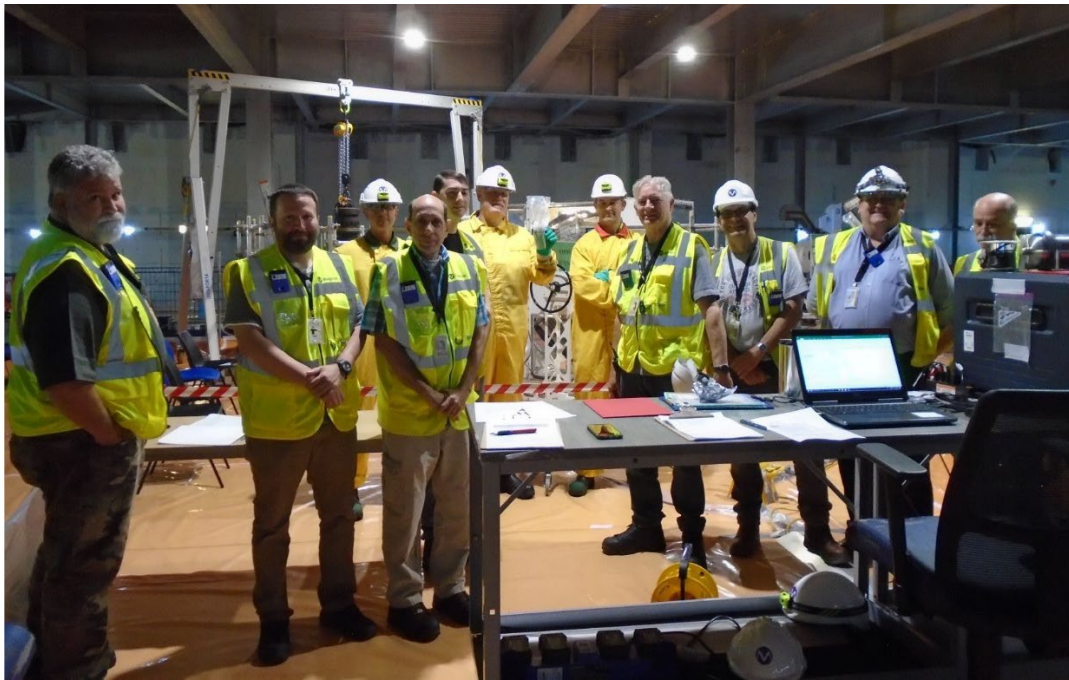
Figure 5. GST and Magnox Staff with the First Reactor 1 Sample on July 18, 2022.

- Weeks 2, 3, and 4: Collected samples. Figure 5 shows the team with the first sample taken from Reactor 1. Weekly sample totals are shown in Table 2. Collection rates ranged from one to six samples per day, averaging 3.5 per day for the 14 days of sampling. Interruptions to sample collection operations are discussed below.
- Week 5: Dismantled systems and repacked releasable equipment in shipping crates. All crates were returned to the ISO containers, which were then locked and sealed by Magnox staff. Contaminated equipment (the sampler, maintenance box, and overview camera) was wrapped in plastic and will be stored in a C2 contamination area until decontamination or packaging as a radioactive shipment.

- Between standpipes, replacement/removal of SCAs must be completed. This required the use of the A-frame hoist seen in the background of Figure 5. For each standpipe two SCAs were removed, one each for the sampler and overview camera. Magnox staff completed this function, usually within an hour.
