# Monitoring of Corrosion in ORGDP Cylinder Yards

H.M. Henson<sup>1</sup>, C.R. Barlow<sup>2</sup>, J.L. Frazier<sup>2</sup>, K.T. Ziehlke<sup>3</sup>

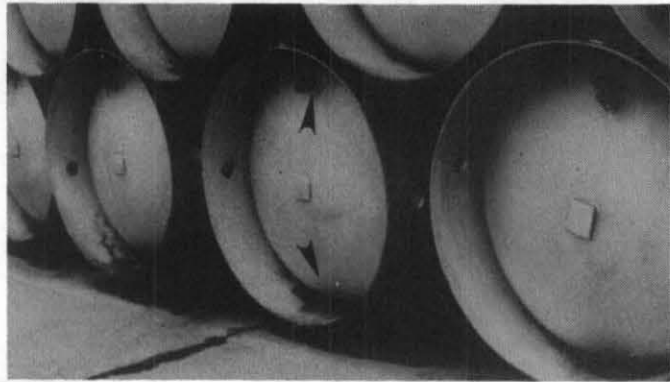
Fig. 6. Cylinders in storage at K-1066-K cylinder yard. Regions where accelerated corrosion attack might be anticipated are (a) lower head region, (b) areas in which dissimilar metals are in contact, (c) weld regions, and (d) areas where the cylinders rest on saddles. These regions are indicated with arrows.
