Impact Test Qualification of 500-Litre Drums for Long-Term Storage*

G. Lawrence, A. Sparkes, M. Constable, J. Williams
AEA Technology

Test series A : Impact Studies of 500-l Drums Containing Cemented (Simulated) MTR Liquor

Test series B : Impact Studies of 500-l Drums Containing Supercompacted 220-l Drums

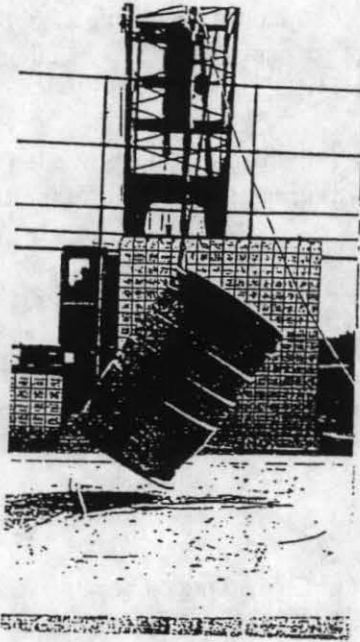
Fig 2. Lid drop attitude

Three drop-tests were performed on two prototype packages : a 1m drop onto the lid and a 10m drop onto the side of the first drum, and a 10m drop onto the lid of a second drum (Fig. 2).

On impact, the grout lid broke free and some 0.68 kg of capping grout was released. The drum came to rest in the upright position about 250cm from its point of impact. Knockback was measured at 95mm for a distance of 560mm around the rim. The deformed surface area was 600cm² with an associated volume change of 1.5 litres. The surface water detection cap was displaced, but remained attached. Examination of the impact zone revealed two cracks on the welded joint between the lid and the strengthening feature (Fig. 6). One fissure was 0.6mm wide x 195mm long, and the second was 1.7mm (max) x 180mm. Both penetrated by up to 5mm. Subsequent examination showed that the inner surface of the lid sustained a 175mm long crack in this vicinity.

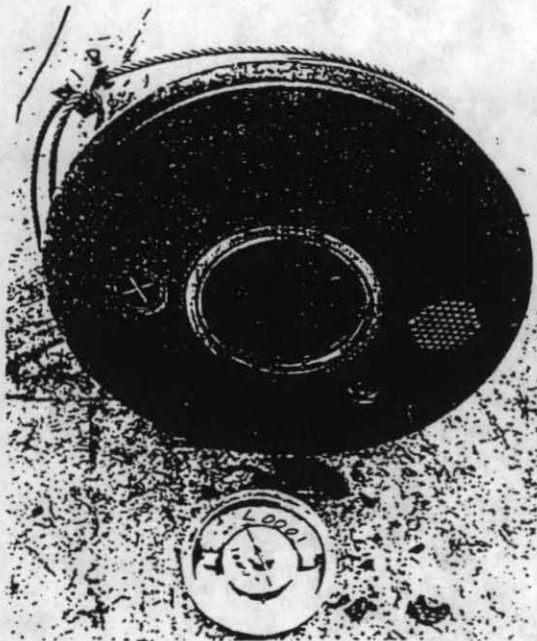
Fig 4. Grout lid detachment

The drum was dropped with its damaged area uppermost. During the final rocking motion after the initial impact, the grout lid became detached because its retaining pins sheared (Fig. 4). This resulted in 0.46 kg of grouted material being ejected. There was no release of simulated MTR product. The drum suffered a knockback of 15mm sustained over a width of around 230mm.

The deformed area was 1,700cm² with a corresponding volume change of about 2 l. The metal skin sustained a 2mm x 210mm crack between the lid flange and the drum sidewall. Post-test particulate analysis on the loose debris showed that 43% of the expelled material comprised pieces greater than 50mm and that 99% of the debris had a minimum dimension of greater than 1.7mm.

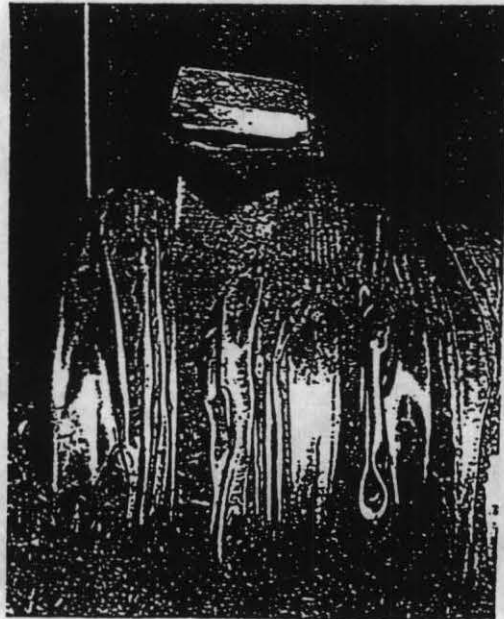
Fig 13. Impact zone puck deformation

The basket was removed, along with some grout, to reveal the condition of the supercompacted pucks (Fig. 13). Details of the punch penetration showed that pucks P1 and P2 had been forced apart and some tearing of the skin was found on P2. The only fluorescent powder observed was that previously seen on puck P6, when the puck was loaded into the 500-l drum. Removal of the base and bottom puck showed that the punch had penetrated 120mm between this puck and the adjacent one. Although there were tears in the skins of both pucks, there was no evidence of fluorescent powder having been released as a result of the impact..
