DROP TESTS WITH THE „RA-3D“ SHIPPING CONTAINER FOR THE TRANSPORT OF FRESH BWR-FUEL ASSEMBLIES

ABSTRACT

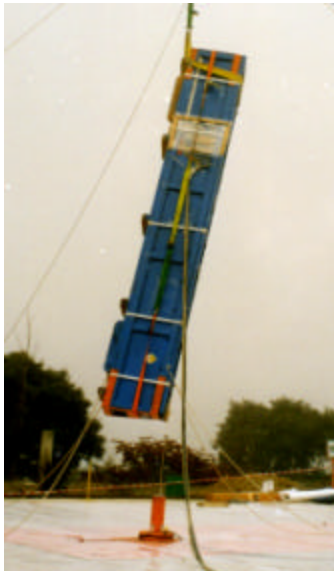
Fig. 2: vertical bar drop (c)

Figure 2 shows the test object in drop position for the vertical bar drop (c). Figure 3 shows the object during the horizontal drop (d) just before hitting the bar.

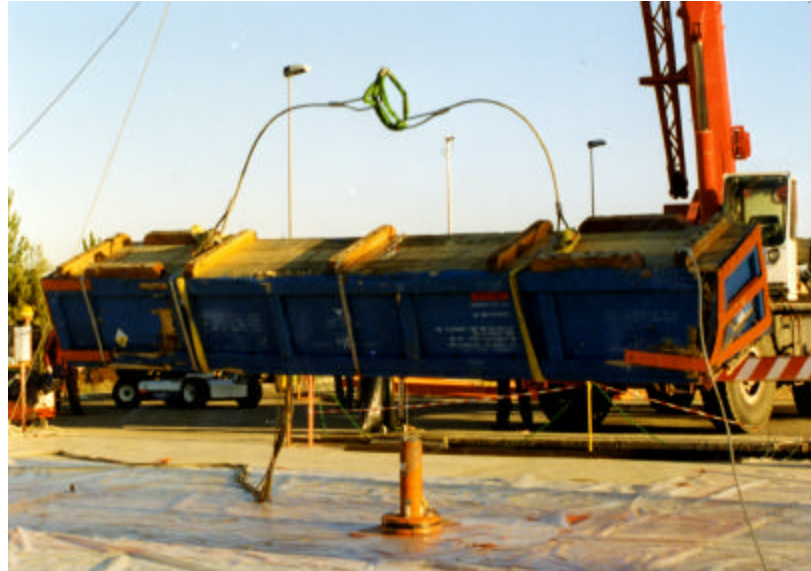
Fig. 3: horizontal bar drop (d)

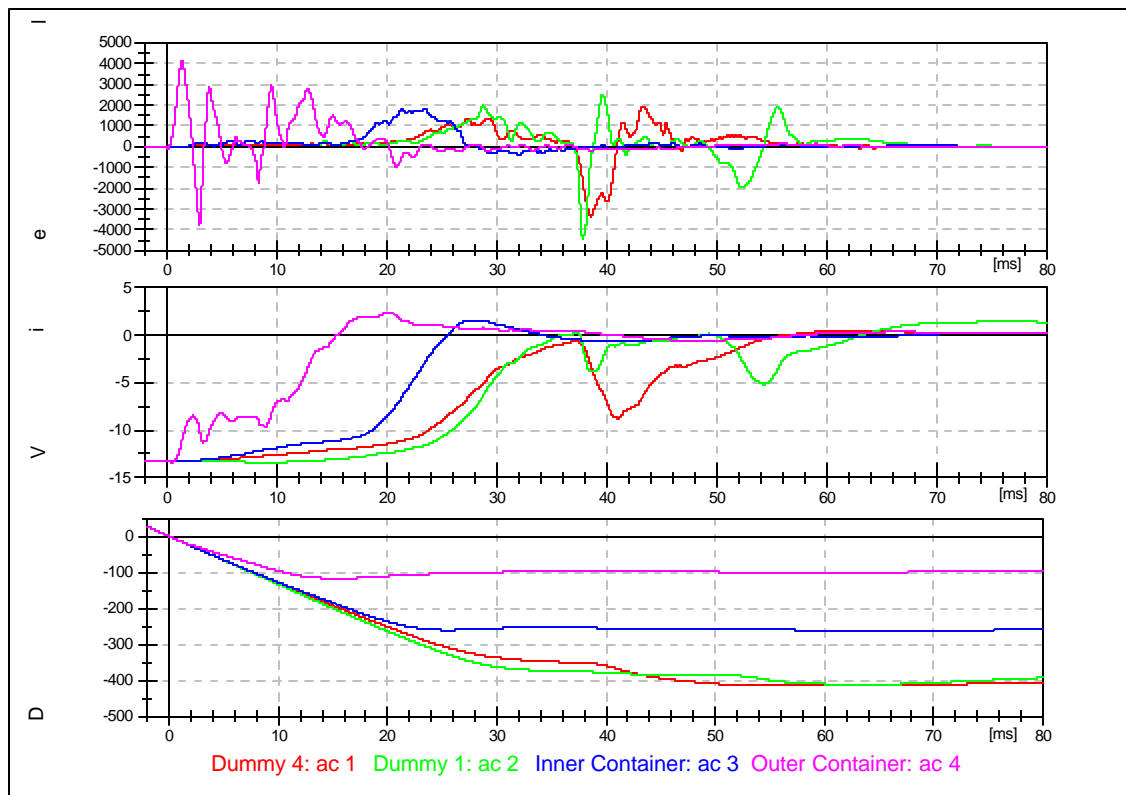
For the 9 m vertical drop (b), an example of the results of the measurements is given in Figure 4, which shows deceleration, velocity, and displacement vs. time. On the diagram for velocity in particular, you can see that the reactions of the inner components of the package were delayed in relation to those of the outer container. This is an effect of the shock absorbing material inside each container.

Fig. 4: deceleration, velocity and displacements from the vertical 9 m drop (b)

The curves for the velocity of the inner components show two phases, a first one with a soft rise of the curves, and a second one with a strong rise. In the first phase, the rise of the curves was nearly identical to the one that occurred in the 1.2 m drop (a). Here the shock absorbing material was still working. In the second phase, the compressible materials were fully compressed. Therefore, the deceleration of the inner container and the fuel assemblies rose to values nearly ten times higher than in the first phase. In the curves for the fuel assemblies, the shifts to negative velocity result from the buckling of the handles.

The curves for the displacement show that the inner container had moved ~ 160 mm, and the fuel assemblies had moved ~ 150 mm relative to the outer container. When the container was opened after the test sequence, these values were confirmed by static control.

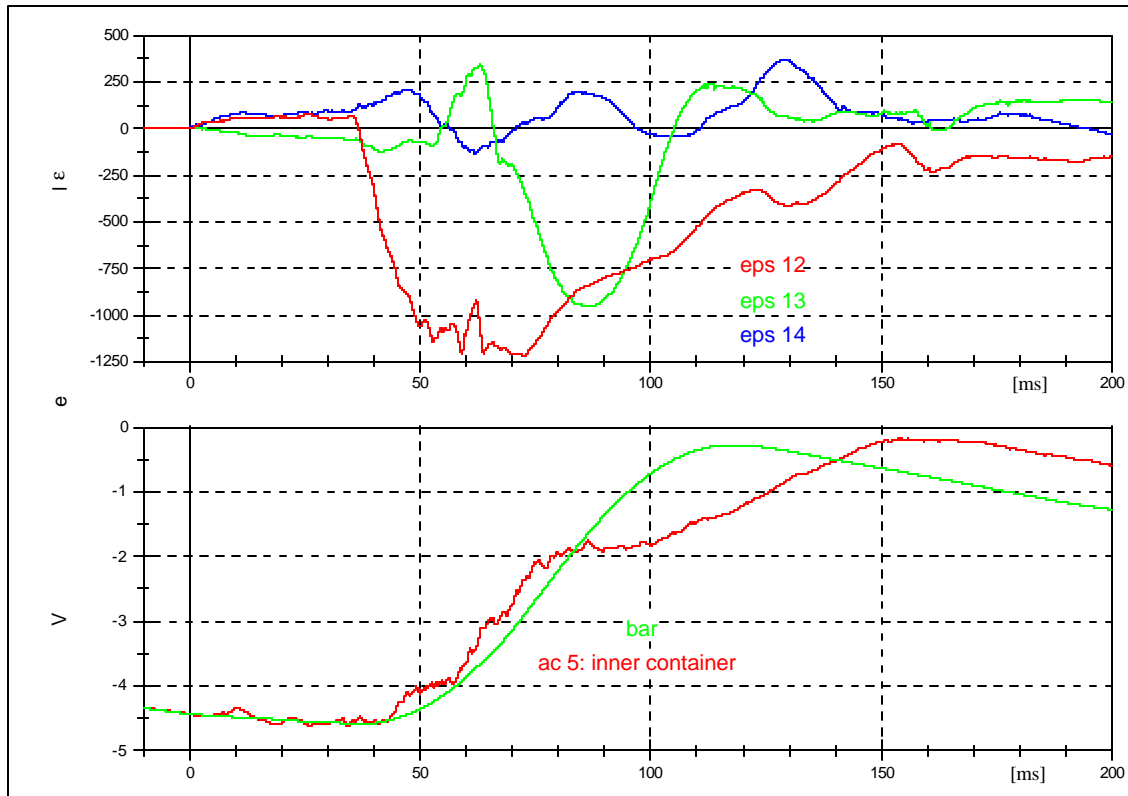
As to the bar drop on the lid side (d), Figure 5 compares the measured strain in the middle of three rods with the velocity curve that was taken from an accelerometer placed in the middle of the bottom side of the container. It shows that when the bar penetrates the wooden container (during the first 40 ms) there is nearly no effect on the velocity or the bending of the rods.

Fig. 5: rod strain and velocity from the horizontal bar drop (c)

When the bar hits the inner container and buckles its lid (depth ~ 76 mm), we observed peaks of high (bending) strain.

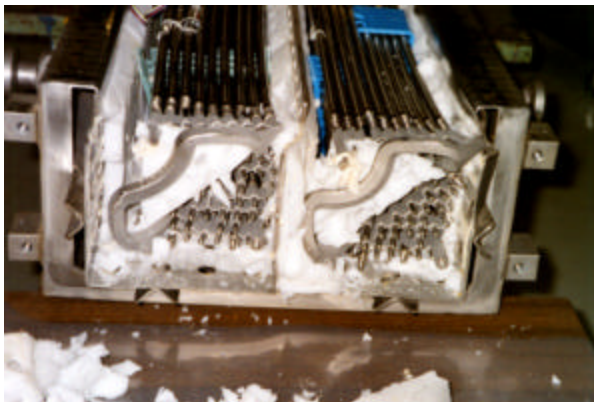
Fig. 6: deformation of the handles after test sequence no. 1

Figures 6 and 7 show the situation of the foot and the head side after opening the inner container test sequence no. 1.

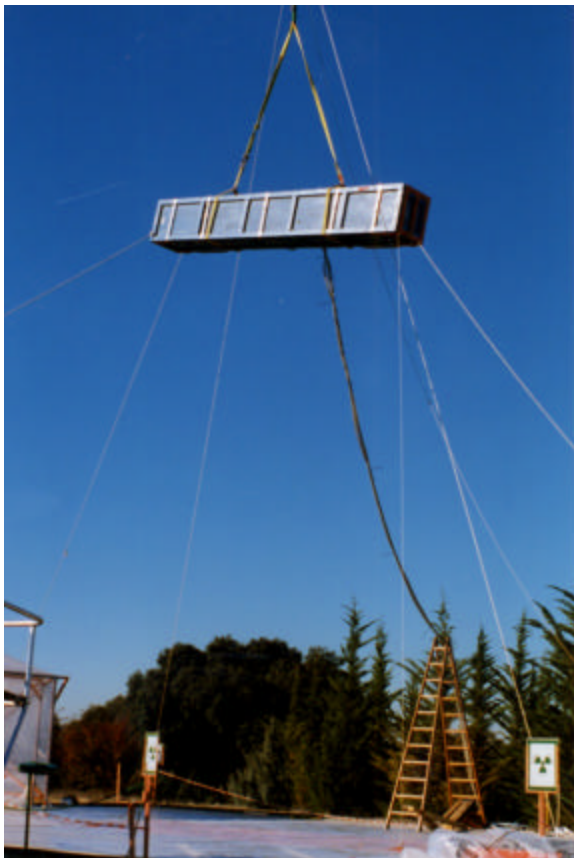
Fig. 8: RA-3D in position for 9 m slap down drop (f)
