## **Cleaning and decontamination of cooling fins on spent fuel transport casks.**

Peter Dybeck, Swedish Nuclear Fuel and Waste Management Co  
SKB  
Box 5864, 102 40 Stockholm, Sweden

Anders Persson, OKG AB, 572 83 Oskarshamn, Sweden

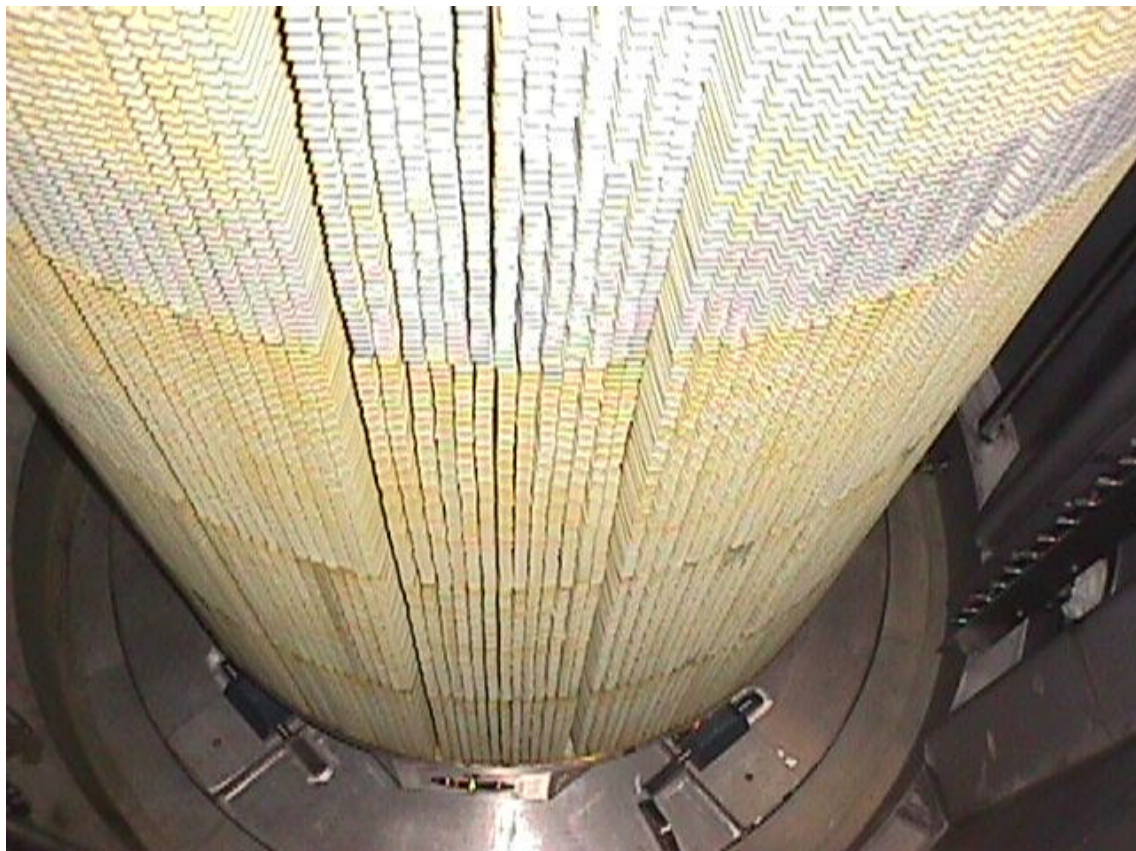
Picture 1 shows a cask standing in the cleaning equipment with the top section brushed. One can see the difference between brushed and non-brushed area clearly enough.

The equipment was ready for use at the end of the last year, 2000. To get rid of the oxide layer on the cooling fins we selected a brush made from artificial fiber with an abrasive mixed into the material. This type of brush should remove the oxides. It proved to be effective and we were successful in removing this layer of oxide and greatly improve the surface appearance of the fins.

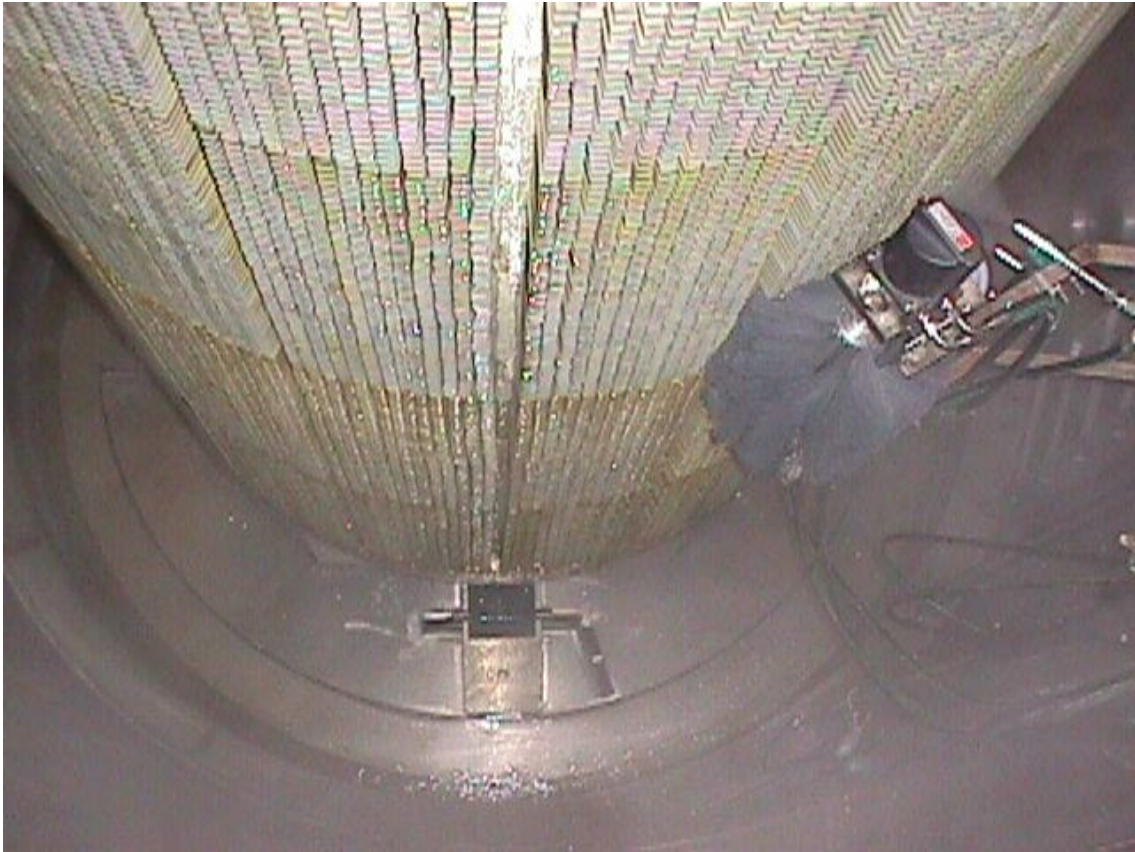
Picture 2

In picture 2 the brushing apparatus can be seen in operation with about half the transport cask finished and the bottom half still not brushed.
