**EARLY STRUCTURAL TESTING OF TYPE B RADIOACTIVE MATERIAL PACKAGES IN THE US TO ENVIRONMENTS BEYOND THE REGULATORY PACKAGE STRUCTURAL TEST STANDARDS**

**ABSTRACT**

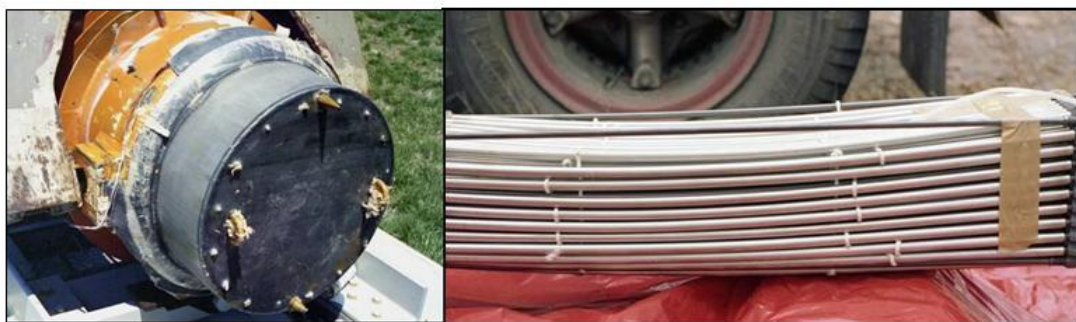
The cask was later used to study the damage that could occur to a fuel assembly it might be transporting. An un-irradiated fuel assembly designed for the NS Savannah merchant ship was made available. The assembly was placed in the cask cavity on a positioning framework. The cask was suspended at about a 30° angle to the horizontal and dropped from a height of 9 m to provide what is commonly called a “slap-down” test environment. When the cask was opened and the un-irradiated fuel assembly was removed (see Figure 3b), it was evident that it had sustained significant damage and parts of the hardware holding the fuel rods in place had broken; however, there was no evidence of the fuel pins rupturing.

Fig. 3. (a) The closure end of the 20.5 t cask with the impact limiter removed after the 9 m end-on impact; (b) the NS Savannah fuel assembly following the 9 m slapdown impact test.

Some fuel pin buckling occurred as shown in Figure 8(b). This buckling was similar to that experienced by a comparable fuel assembly in the regulatory drop tests (see Figure 3(b)); however, no clad failure was detected.

A ballasted, un-irradiated NS Savannah merchant ship reactor fuel assembly that was in the cask during the locomotive impact experienced some bowing of the fuel pins in the fuel assembly; however, no clad failure was detected. In addition, the effects on the fuel assembly from this accident-simulating test were compared directly with the effects on the fuel assembly in the regulatory 9 m slapdown drop test as shown in Figure 3(b)). More bowing of fuel pins was observed in the slapdown test than in the locomotive/cask impact test.

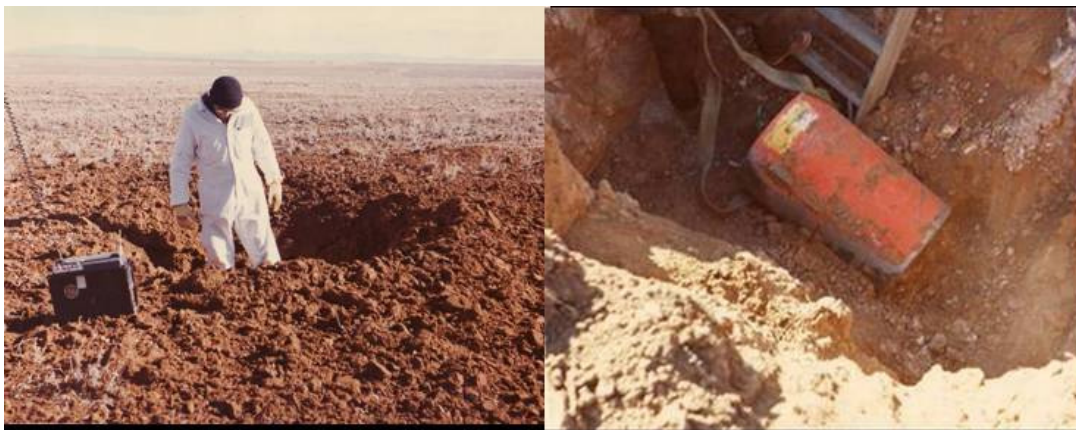
The BE-83 cask design that was tested for the 9 m regulatory drop described above was first tested. During the drop test, the cylindrical axis of the BE-83 cask rotated from the vertical by approximately 100° during the 610 m descent, resulting in a near side-on impact with the closure end slightly lower. The impact velocity was 110 m/s. Figure 4(a) shows the hole in the desert after impact before excavation; the case was completely buried to a depth of 2.44 m during the impact. Figure 4(b) shows the cask after it was excavated. No significant deformation was observed. The lifting lugs were sheared off as a result of the combined impact and recovery effects. No observable lead slump was observed.

Fig. 4. BE-83 cask (a) completely buried as the result of 610 m drop from helicopter onto hardpan desert soil; (b) after excavation.

Even though the impact velocity was substantially higher, there was less damage to the cask from the 610 m drop onto hard prairie soil than there was for the 9 m impact test conducted at ORNL which, as noted previously, suffered weld failures in the outer shell of the cask. Despite the more significant structural damage in the 9 m impact test, both casks would have safely contained their contents without release.

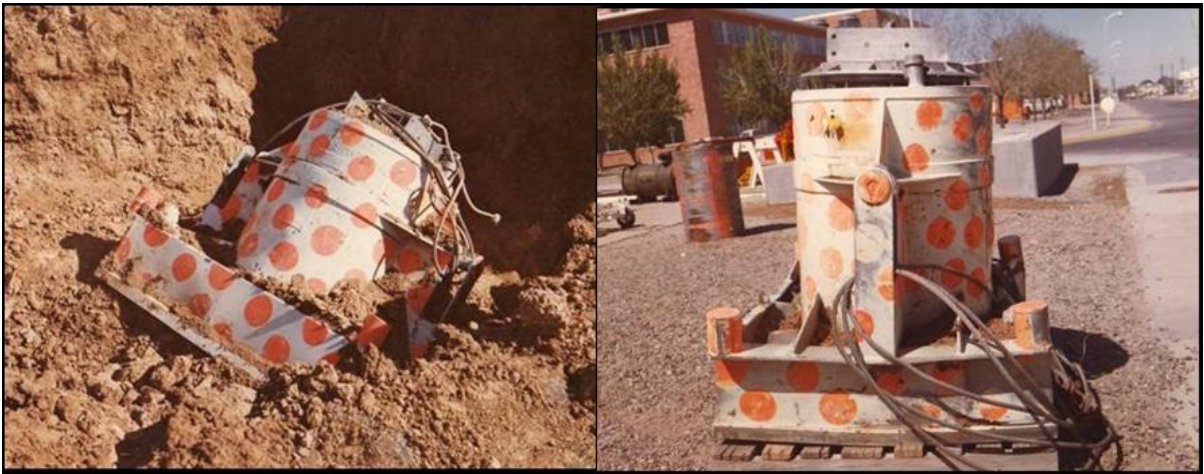
An obsolete Oak Ridge Research Reactor OD-1 Spent Fuel Carrier, which was originally approved by DOT under Special Permit No. 5660 to ship ORR-type irradiated fuel elements, was a stainless steel clad, lead shielded upright cylindrical container with square base weighing 7410 kg. It was also dropped from a helicopter under the same conditions as the BE-83 cask. The orientation of the cask was vertical at release from the helicopter, but it rotated approximately 30° during its descent from 610 m. The tie-down (square) plate was the first part of the cask to contact the ground. The cask was buried to a depth of 1.28 m into the earth, and the impact velocity was 103 m/s. The partially excavated cask is shown in Figure 5(a); the fully excavated cask is shown in Fig. 5(b). The tie-down plate was deformed, with its superstructure crushed at the point of impact. The lead shielding inside of the outer shell slumped approximately 20 mm with respect to the outer shell. The cask displayed slight bulging at a point 15 percent of the length above its base. The closure bolts, located in ring on the top, were all canted inward, which made the closure plug difficult to remove. Measurements of the inner cavity indicated a reduction of about 1 mm in its diameter. The inner basket was not visibly damaged, but it was difficult to remove because of the inner cavity distortion.

Fig. 5. OD-1 cask (a) during excavation after 610 m drop from helicopter onto hardpan desert soil; (b) after excavation.

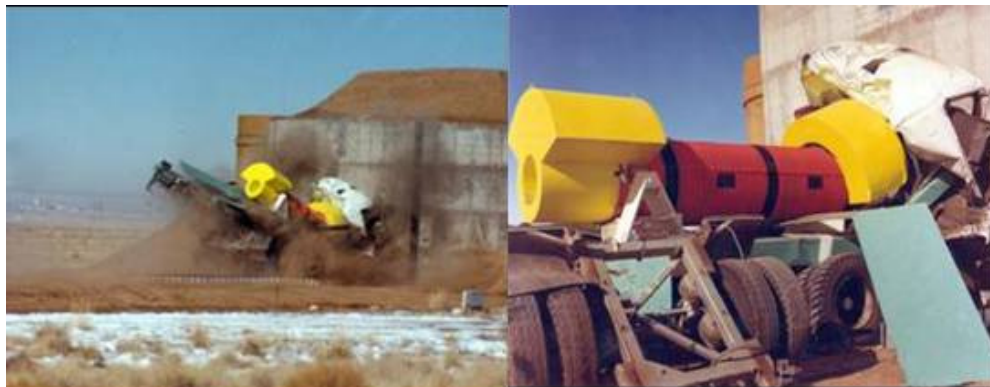
Figure 6(a) shows the cask and transport system during the 100 km/hr test; and Figure 6(b) shows the cask and transport system following the impact. As predicted by the pretest analyses, the tractor was completely destroyed in the crash. Although the cask tie-downs did not break loose during impact, posttest inspection of the debris indicated that the cask tie-downs had been close to failure. The cask remained intact, sustaining only superficial damage to the external surface. The cask head was easily removed, and the fuel assembly was found to be intact and undamaged.

Fig. 6. 20.5 t SNF cask/transport system (a) during impact of at 100 km/hr; and (b) following impact.

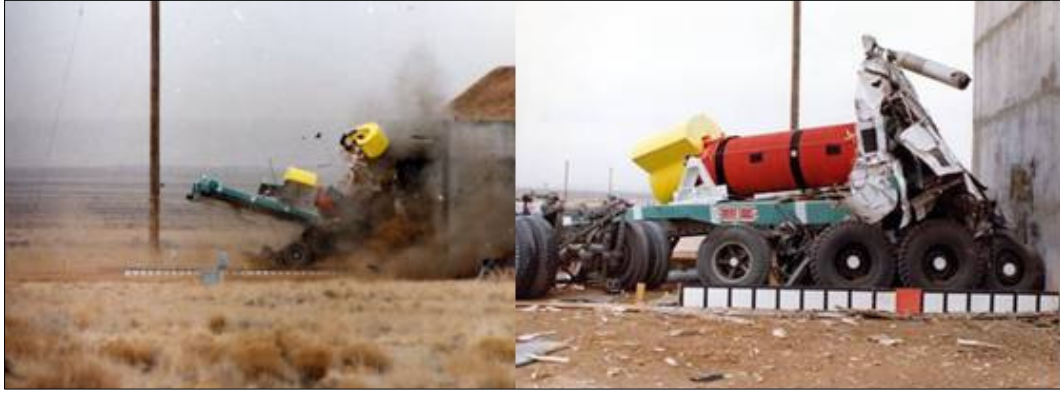
Since the cask sustained little damage in the first test, it was cleaned, repainted, loaded with a fuel assembly, and remounted on an identical tractor/trailer transport system for the second test at greater impact velocity. The second test was conducted at a velocity of 135 km/hr. The tractor and trailer were demolished and a portion of the impact limiter in contact with the cask was completely crushed even though the tie-downs held until the final stages of impact. Figure 7(a) shows the truck cask system at impact. Figure 7(b) shows the condition of the cask and transport system after the impact test.

Fig. 7. 20.5 t SNF cask and transport system (a) during impact of at 135 km/hr; (b) following impact.

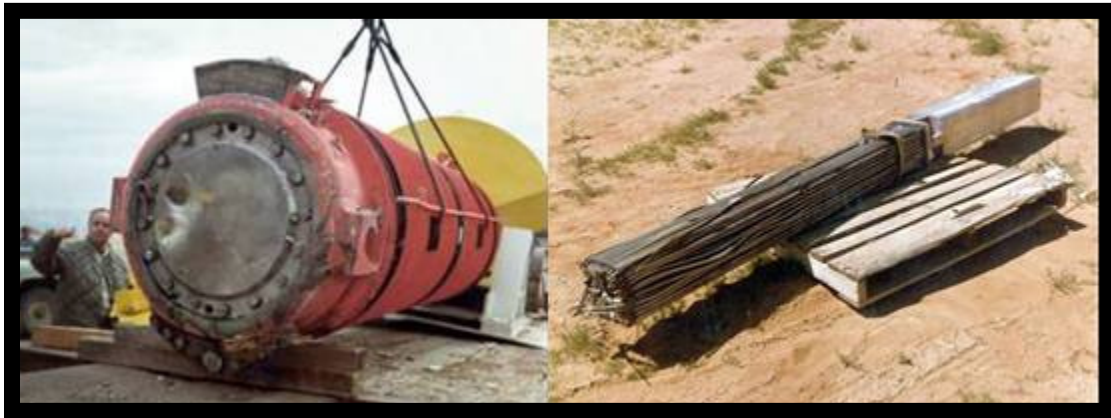
After removal of the cask from the trailer, seepage at the rate of about two drops of water per minute was detected from the cask head. The seepage later stopped after approximately 100 cc of fluid was released. As shown in Figure 8(a), the lid of the cask was “peened” onto the cask body. The front of the cask had bulged as predicted. Several dents found on the surface of the cask head were caused by the impact of the cask with the trailer fifth wheel pin, which was forced in front of the cask by the buckling of the trailer. The cask head was removed with great difficulty after which inspection of the fuel assembly revealed deformation at the impact end.

Fig. 8. The 20.5 t cask (a) head end after 135 km/hr impact; (b) condition of fuel assembly with ballast after the 135 km/hr impact.

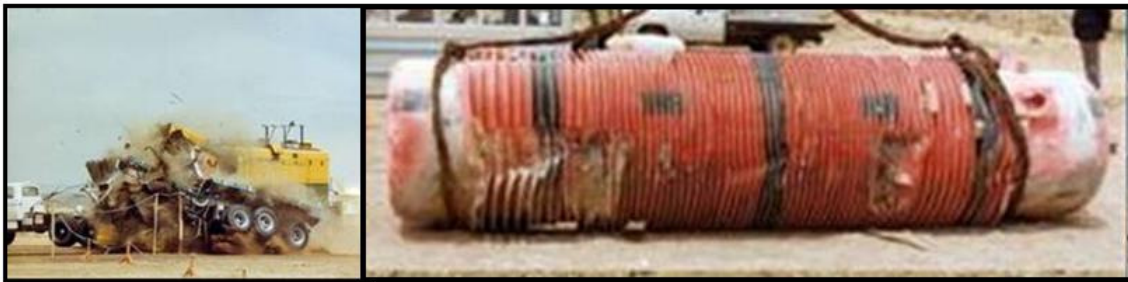
Grade crossing impact test of 109 t rail locomotive into the 22.7 t truck-mounted cask: An obsolete 22.7 t cask was impacted by a locomotive traveling at 130 km/hr. Figure 9(a) shows the locomotive and truck cask and trailer during impact at 130 km/hr. Figure 9(b) shows the resulting damage to the full scale cask. Leak testing of the cask after impact indicated a small leak in the head seal, when the cask was pressurized. However, it was determined that, had the cask contained cooling water as it was originally designed to do, this leakage would have caused essentially no risk to the public. The cask head was removed without difficulty and the fuel was found to be intact with only slight bowing.

Fig. 9. Locomotive (a) impacting the truck cask and trailer at 130 km/hr grade crossing test; and (b) post test damage to the cask.

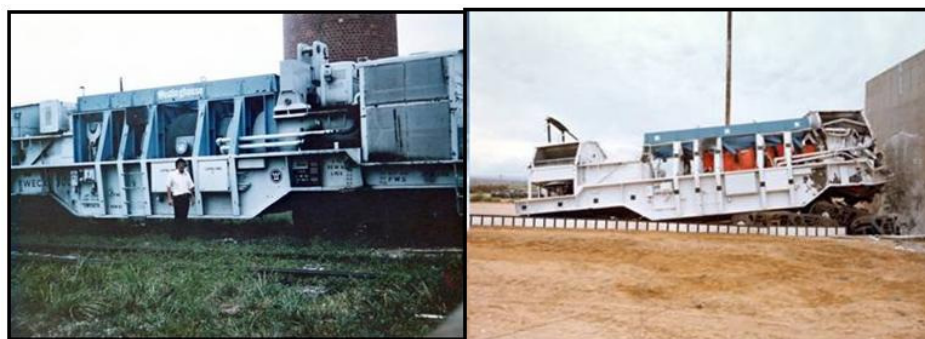
The full scale test was conducted at a velocity of approximately 130 km/hr. Figure 10(a) shows the railcar and cask before impact, with the array of rockets that were used to propel the system to the impact speed. Figure 10(b) shows the railcar and cask after impact. The impact resulted in extensive damage to the railcar structure but the damage to the target was minimal and target deflection was negligible. The cask body was un-deformed except for minor deformations to the external cooling fins. There was no leakage. Subsequent examination of the fuel assembly indicated that the fuel pins were undamaged. Only the support bracket at the end of the bundle was slightly distorted.

Fig. 10. Special railcar/cask system (a) prior to testing; and (b) after 130 km/hr impact test.

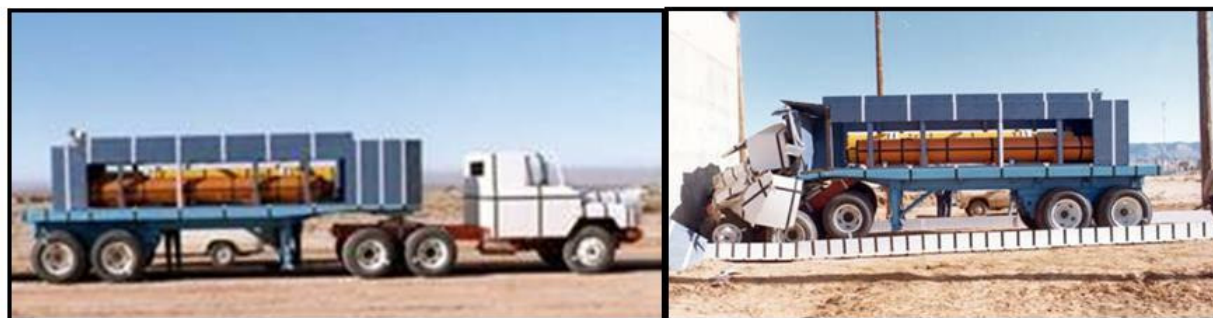
The PNC shipping system that was tested consisted of a special tractor-trailer and a fresh fuel shipping cask for breeder reactor fuel. The full scale test was conducted with a specially constructed system patterned after the PNC prototype that was designed and constructed by SNL. It utilized one cask and two dummy mass modeled casks. Figure 11(a) shows the full scale system prior to the test. The PNC transport system struck the target at approximately 93 km/hr. The system after the impact test is shown in Figure 11(b). After the test, the cask interior was carefully inspected with a mirror and telescope and no defects were found. The cask was also leak-tested, and it was concluded that the cask’s leak tightness was not affected by the impact test.

Figure 11. PNC SNM transport system (a) before 93 km/hr impact test; and (b) after 93 km/hr impact test.
