WASTE CONTAINER DROP TESTS ONTO A CONCRETE TARGET

Packaging and Transportation of Radioactive Materials

Development of a disposal container for the storage of high activity low level waste

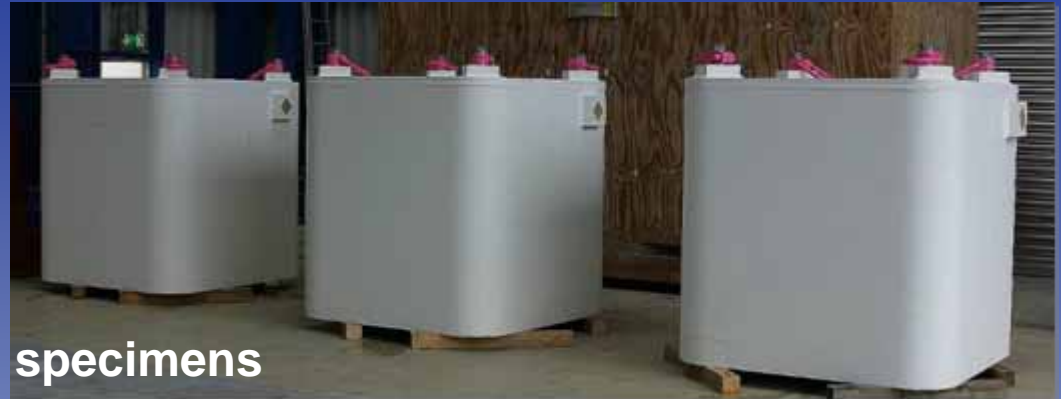
Specimens of the waste package

Specimens

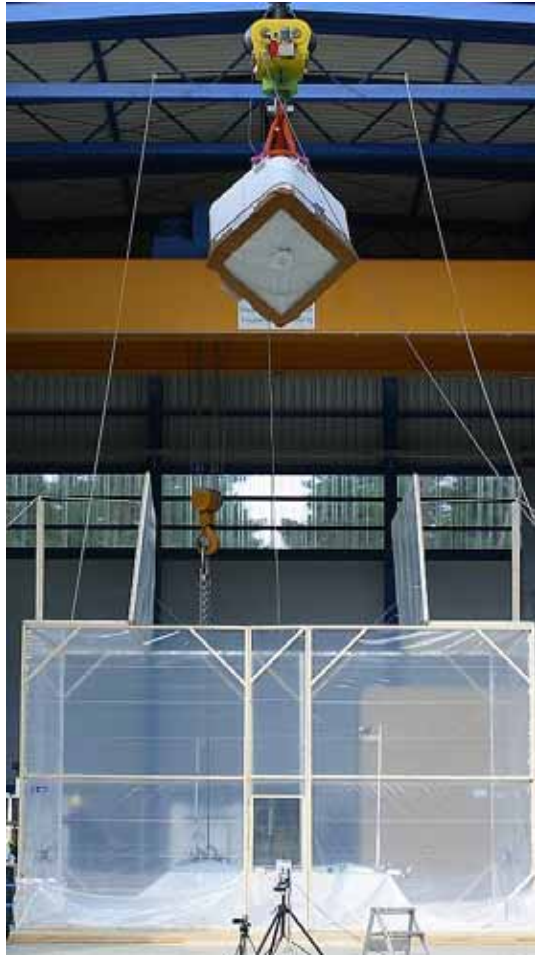
Specimen A

28 150 kg
8-m corner drop

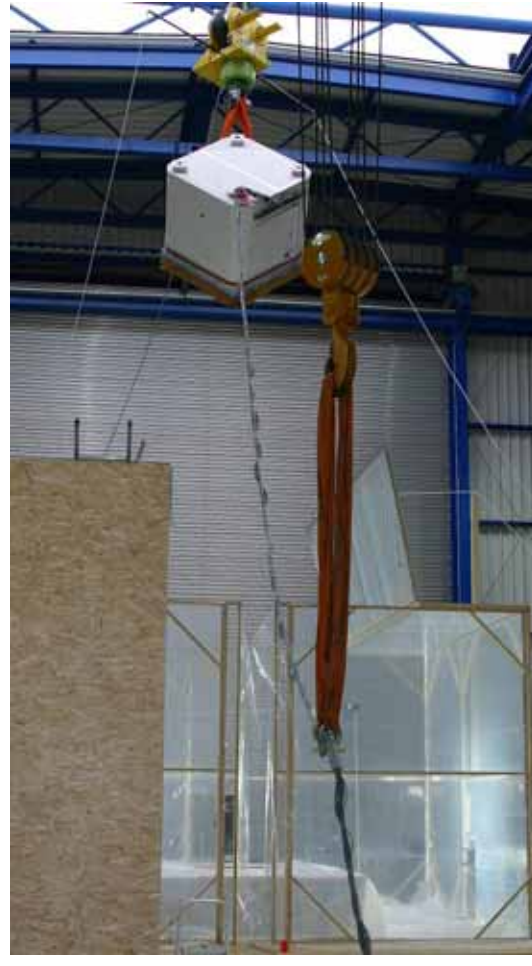
Specimen B

20 450 kg
8-m corner drop

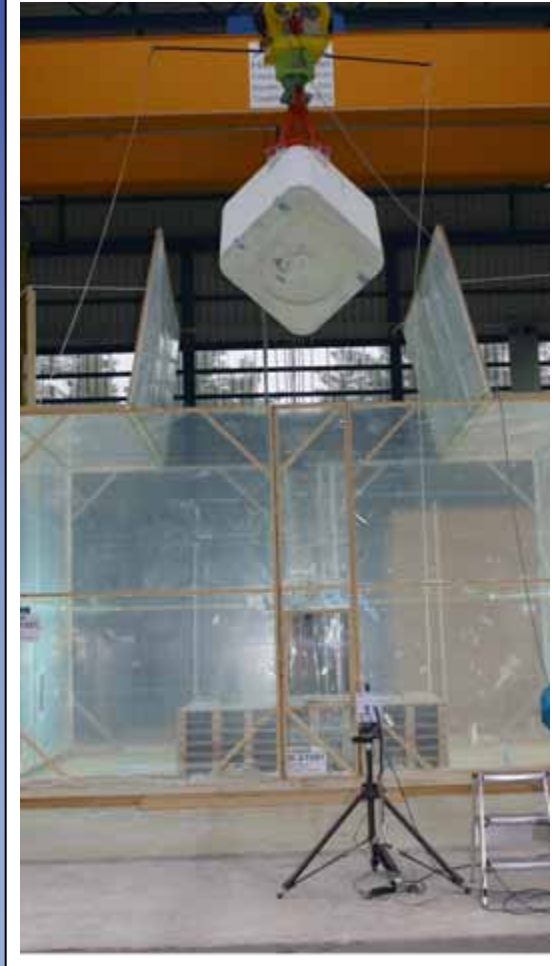
Specimen C

28 150 kg
8-m corner drop

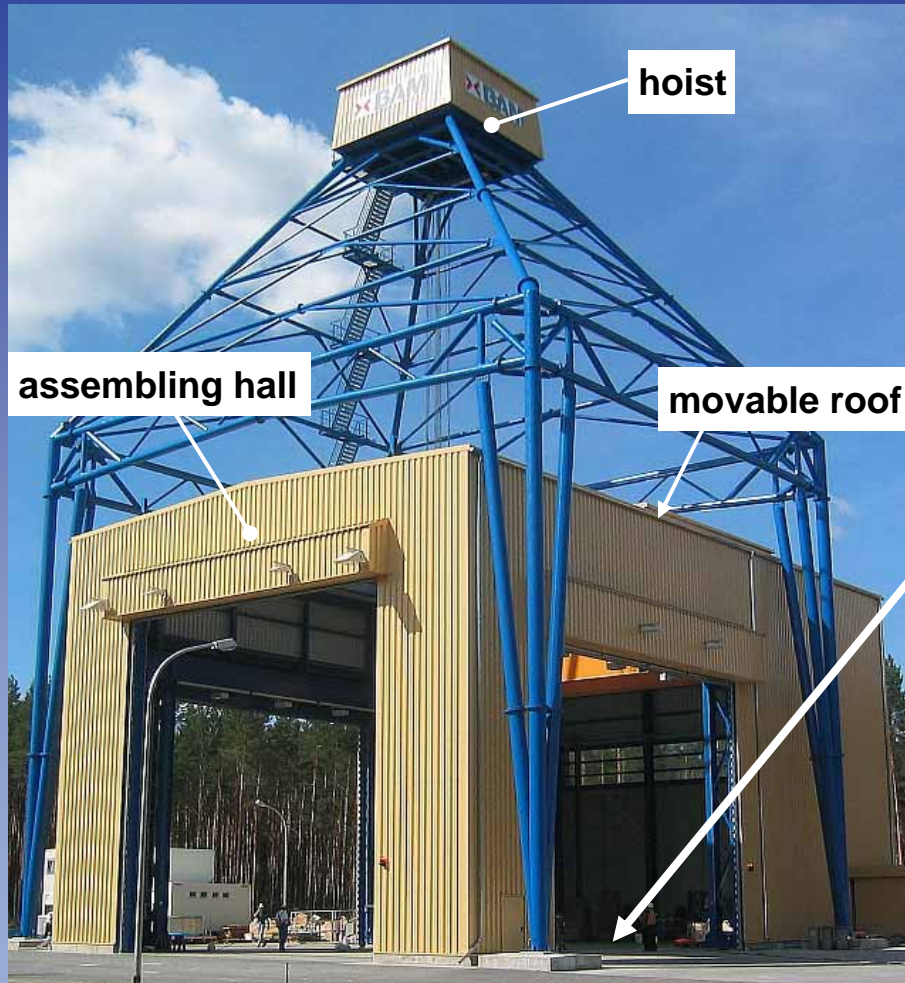
Drop test facility at BAM Test Site Technical Safety at Horstwalde

36-m high drop tower

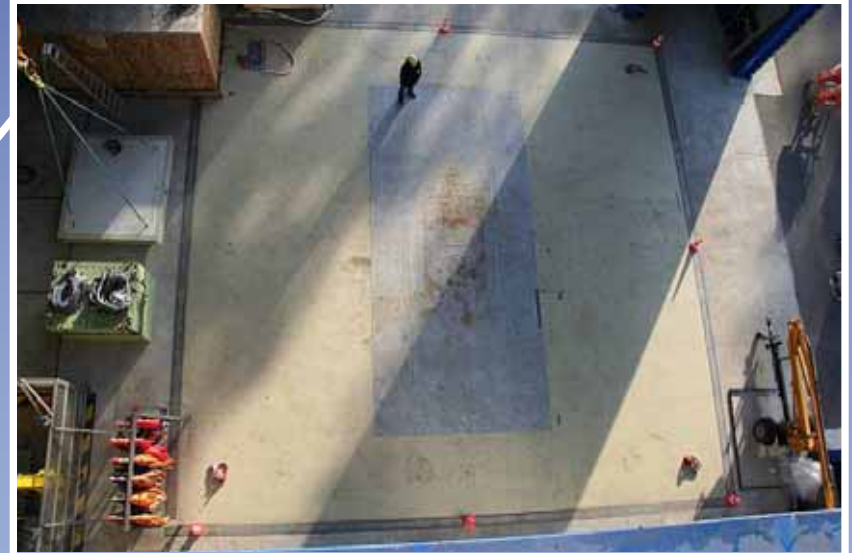
IAEA-target (bird's eye view)

- steel impact pad
10 m x 4.5 m x 0.22 m; mass 77,000 kg
- reinforced concrete target
14 m x 14 m x 5 m; mass 2,450,000 kg

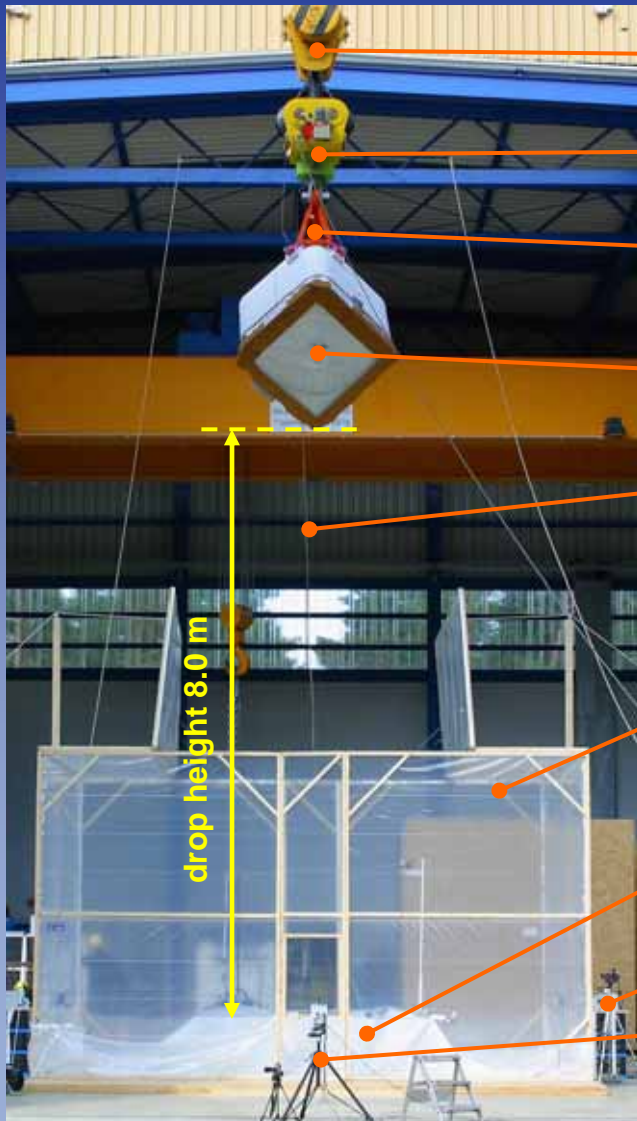
Drop test arrangement

hoist's crane hook

release system

nylon slings for attachment

specimen

measuring cables for strain and deceleration metrology

closed volume construction for particle release measurement

concrete slab covered with vinyl sheet

dust sampler

high speed camera

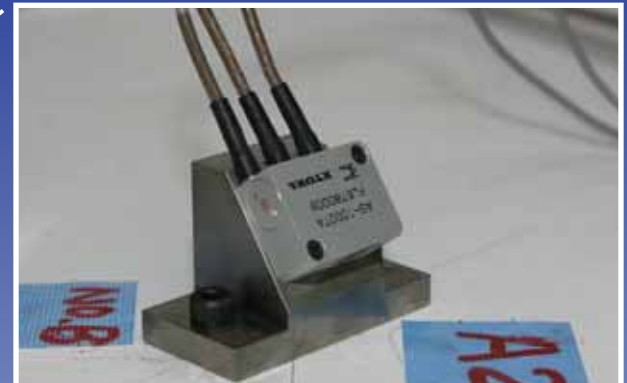
Tri-axial piezoresistive accelerometer

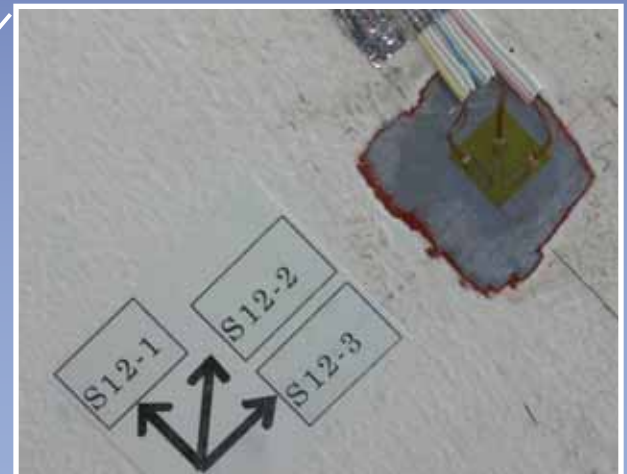
Three axis strain gauge

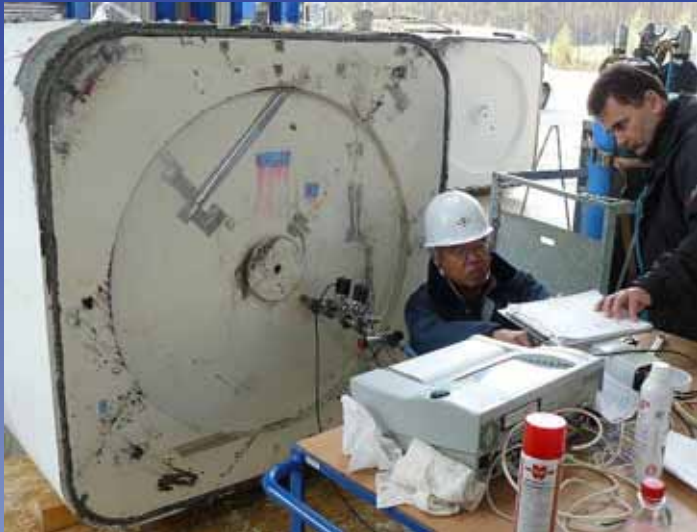
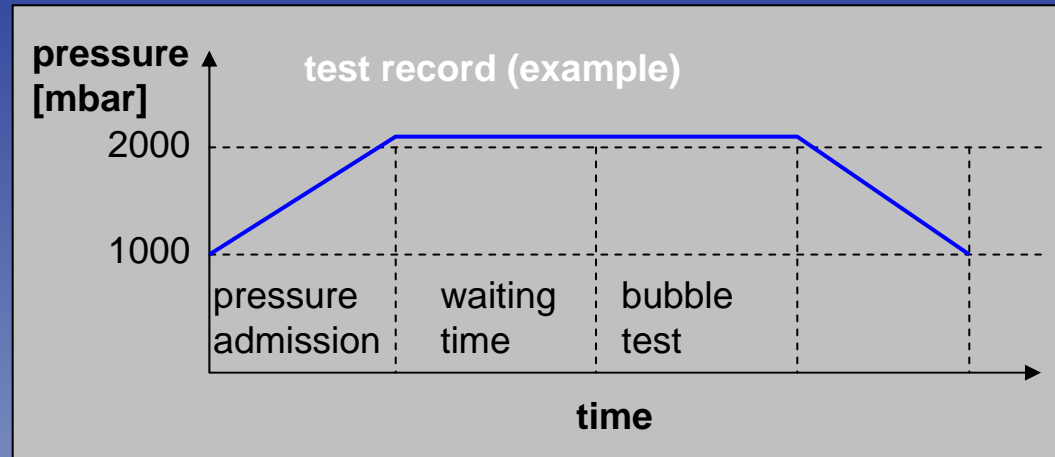
Leakage testing: bubble emission technique

➤ according European Standard DIN EN 1593

➤ pressure admission > 2000 mbar

➤ waiting time for stable conditions > 30 minutes

➤ apply of a liquid surfactant by spray to the whole welding seam and deformed corner edge for tracing possible leaks

➤ after application of the leakfinder spray an observation of any bubbles started

➤ significance: no bubbles → leakage rate at least 10^{-4} Pa m³/s

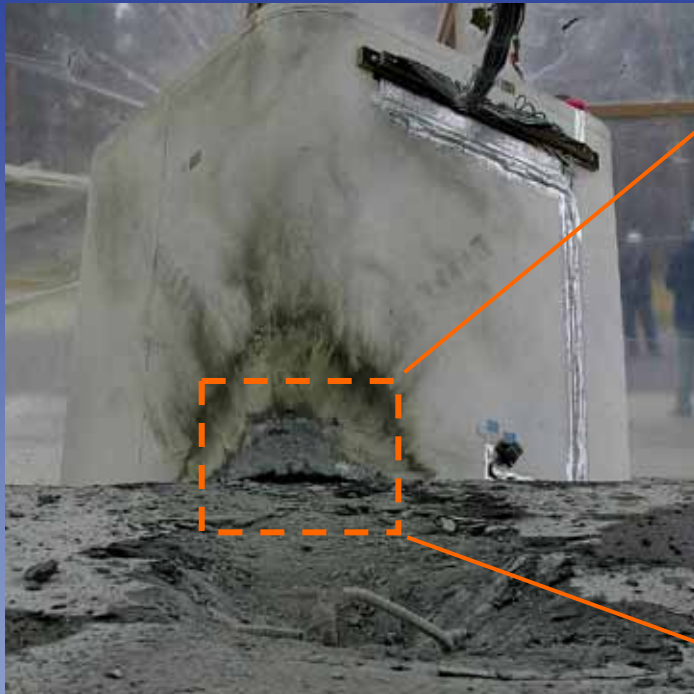
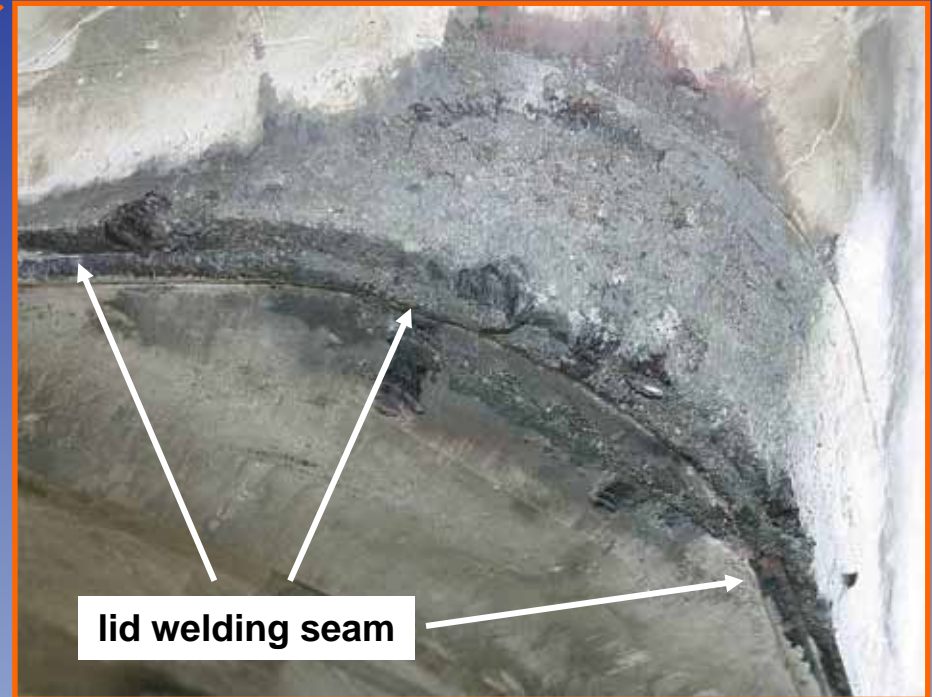
Visual inspection results of the impacted corner edge

- plastic deformation of the impacted corner edge
- lid welding seam visually undamaged except some groovings on its surface
- other parts than the impacted corner edge of the container are visually unaffected by the impact without any visible damages

The visual inspection of the specimens after drop test showed for all three specimens similar results:

- plastic deformation of the impacted corner edge and a visually undamaged welding seam except some groovings on its surface
- other parts of the specimens than the impacted corner edges are visually unaffected by the impact without any visible damages.
- the concrete slabs showed crater-shaped local demolition by the impact of the specimens.

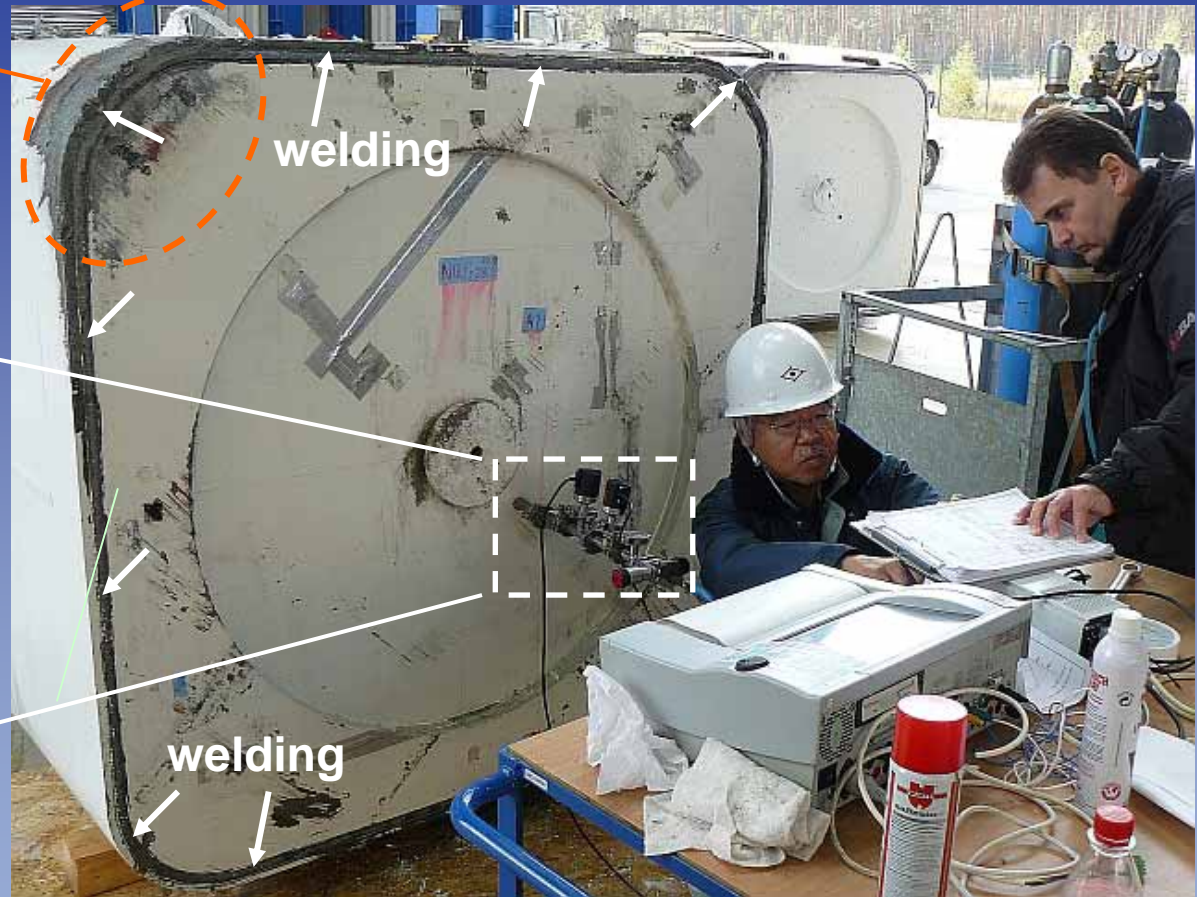
Leakage testing using the bubble emission technique

impacted corner edge

pressure sensor

valve

nitrogen

The leakage test results showed no bubbling at all neither on the welding seam nor on the deformed corner edge for all three drop tests.

The results of the leakage test 'bubble emission technique' according to DIN EN 1593 and DIN EN 1779 show:

- no bubbling on the welding seam for all three specimens
- no bubbling on the deformed corner edge for all three specimens

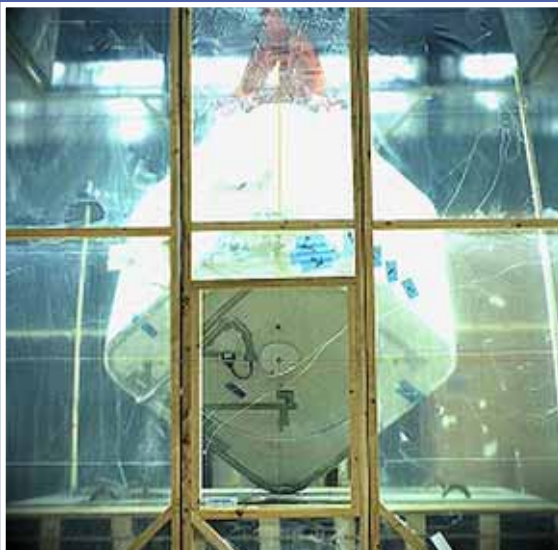
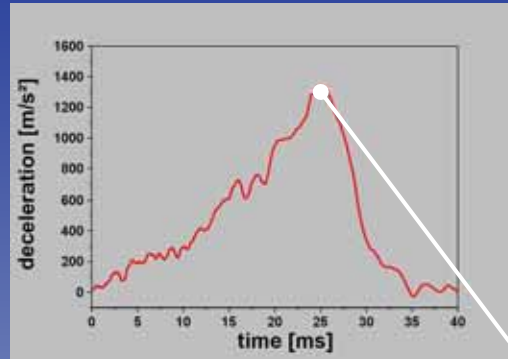
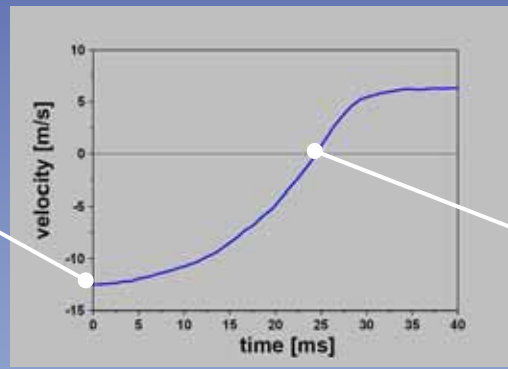
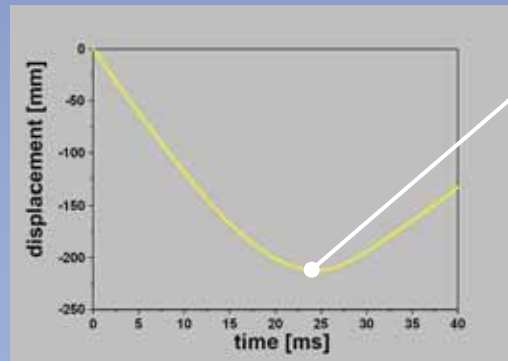
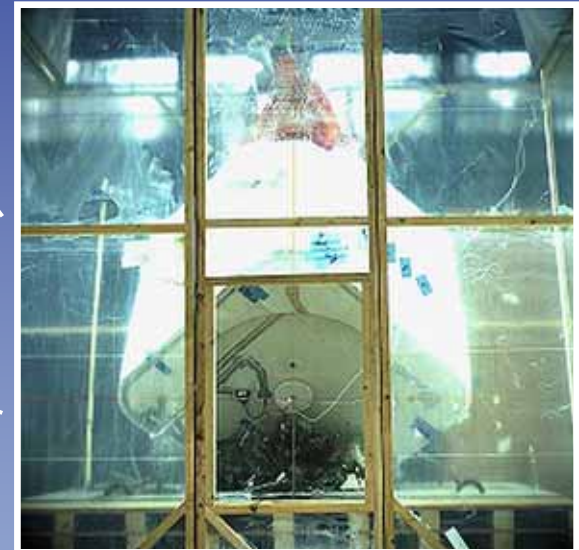
Deceleration measurement: rigid body movement

**First contact;
start of impact
velocity = 12.5 m/s**

**maximum deceleration
and displacement
velocity = 0 m/s**

Maximum rigid body **deceleration** approximately 130 – 140 G;
impact duration 30 – 35 Milliseconds

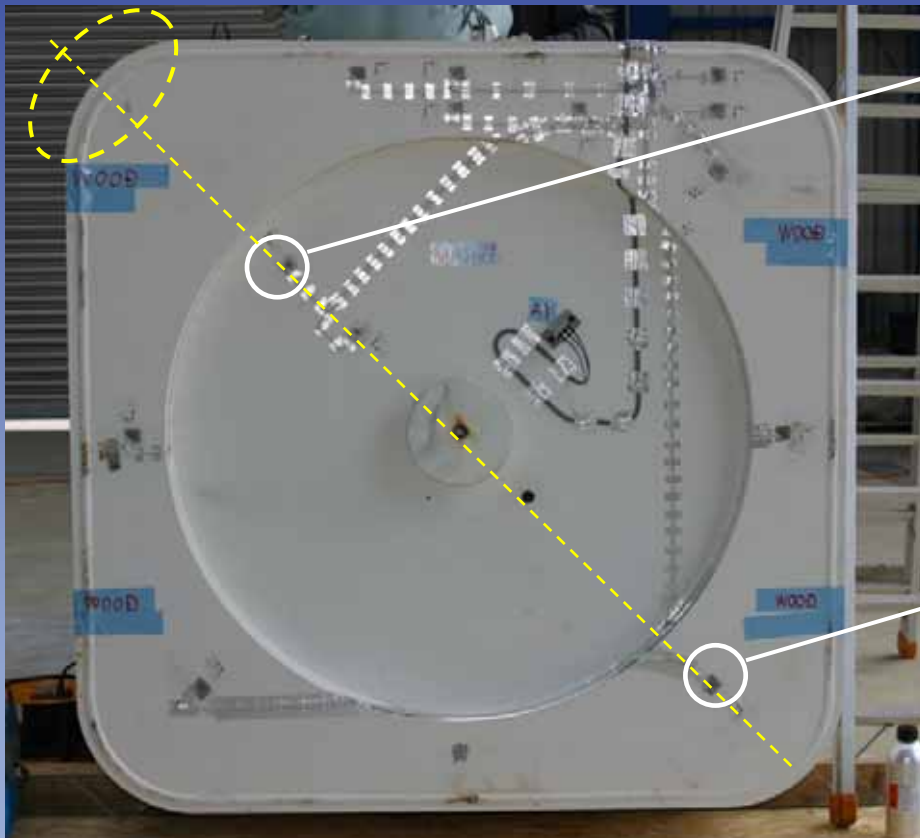
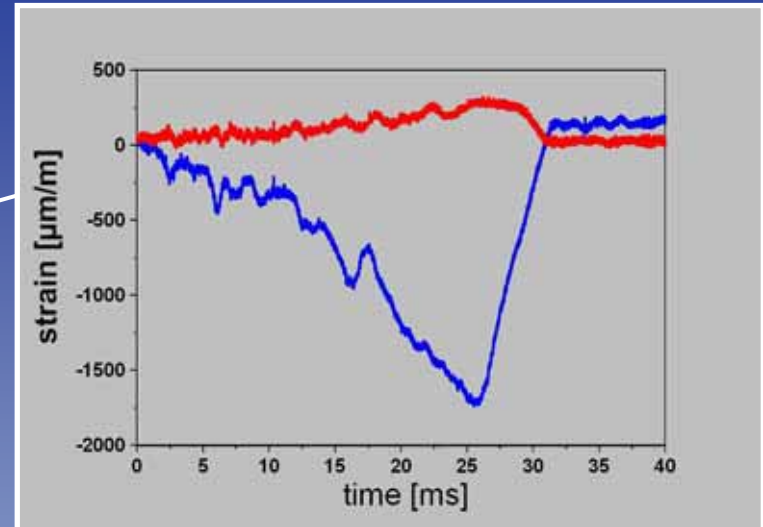
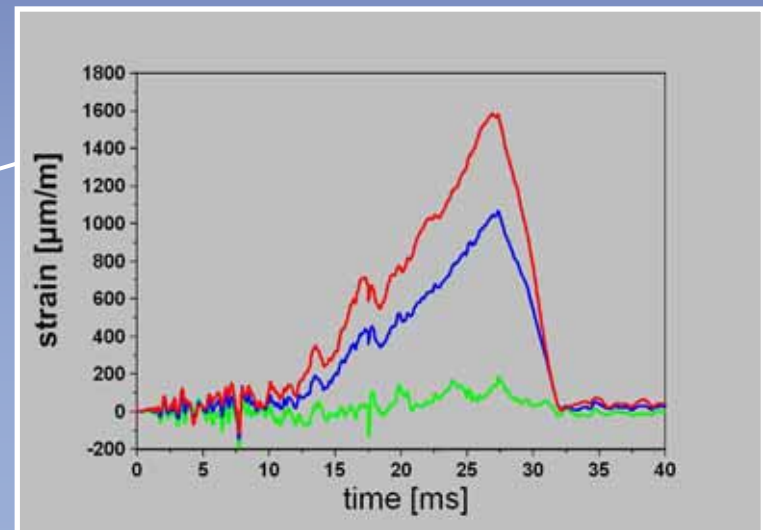
Measured Strain signals

Strain measurement (examples)
