**DROP TESTING OF THE DN30 PROTECTIVE STRUCTURAL PACKAGING  
FOR THE TRANSPORT OF URANIUM-HEXAFLUORIDE**

**Wolfgang Bergmann**

Nuclear Cargo + Service GmbH  
(DAHER-NCS)

**ABSTRACT**

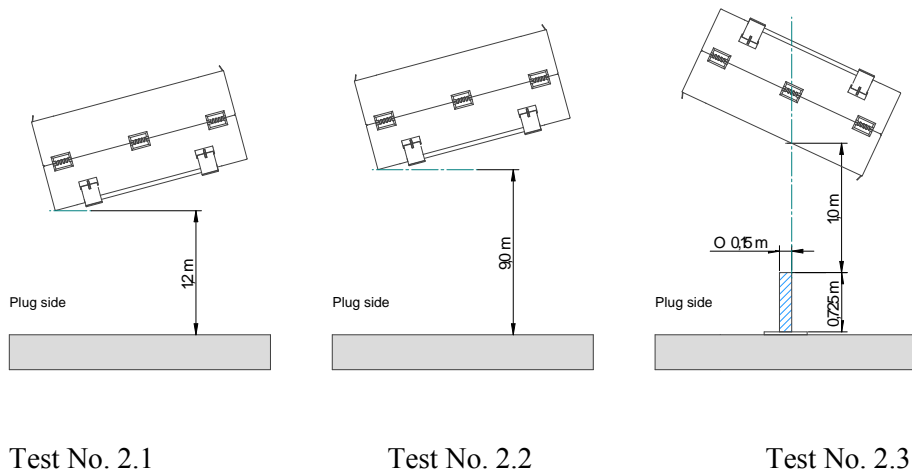
**Figure 3: Drop test sequence 2**

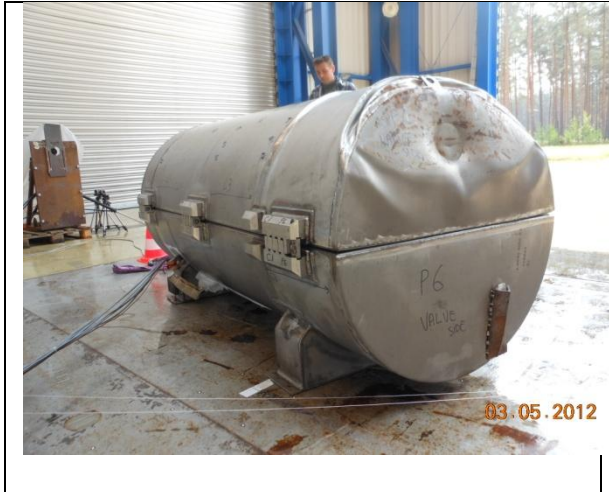
The outer shell of the DN30 was deformed due to the 9 m drop test and 1 m bar drop test. The outer shell showed no cracks (see Fig. 7). No visual damage of the closure system occurred. No contact between valve/plug and DN 30 PSP (see Fig. 8) took place. In the interior the upper half-shell was locally deformed at the valve related front end. The 30B cylinder showed no visual damage. The measured leak rate was acceptable.

**Figure 7: Exterior deformation**

The maximum deceleration during the 9 m drop test was in the range of 300 g (cut-off frequency 292 Hz)

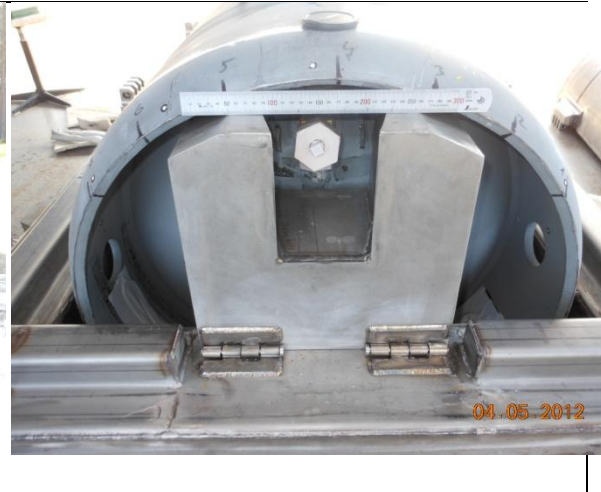
**Figure 8: View of the valve**

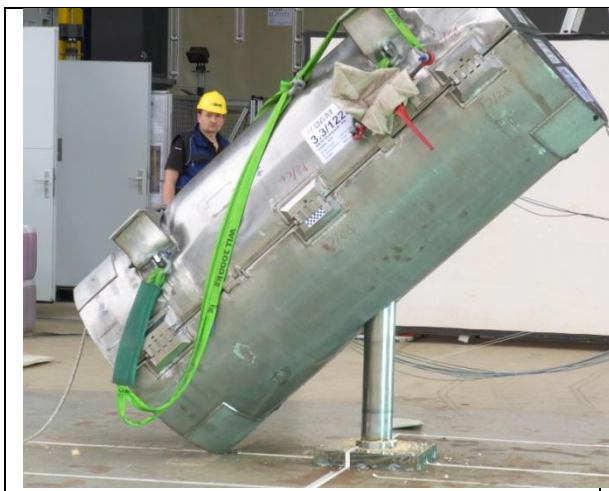
The feet and the outer shell on valve and plug side were deformed due to the 9 m drop test. Punctured shell due to 1 m bar drop (see Fig. 9).

The interior of the lower half-shell was locally deformed by the puncture bar and the 30B cylinder showed a small dent due to the bar drop test. The leakage rate of the 30B cylinder was acceptable.

**Figure 9: DN30 after bar drop**

During the horizontal slap-down drop test (sequence 2) one of the six closures near the second impact side showed cracks, but the top- and bottom-halves of the DN30 were still securely connected by five closures. The result of this test showed that during the horizontal slap-down drop in the closure system the maximum stress occurs compared to the other drop orientations. This is caused by the upward movement of the 30B cylinder during secondary impact. To avoid this issue a new material with higher ductility was selected for the new design.

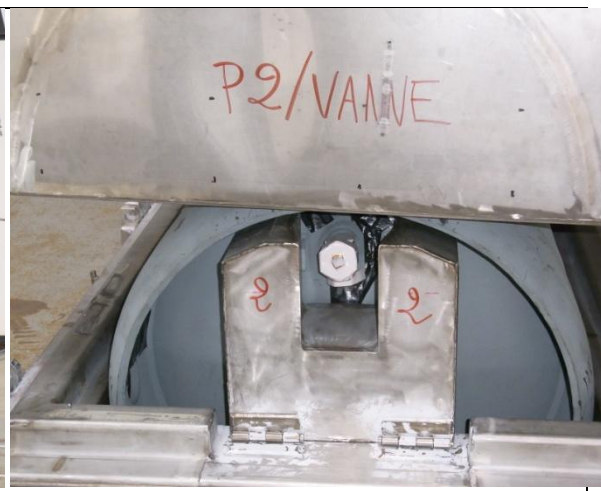
There was no visual damage of the closure systems C1 to C5. Closure system C6 near the valve side was broken. All closure pins were undamaged and upper and lower half-shell were securely connected. No contact between valve/plug and DN 30 PSP occurred.

**Figure 10: View of the valve**

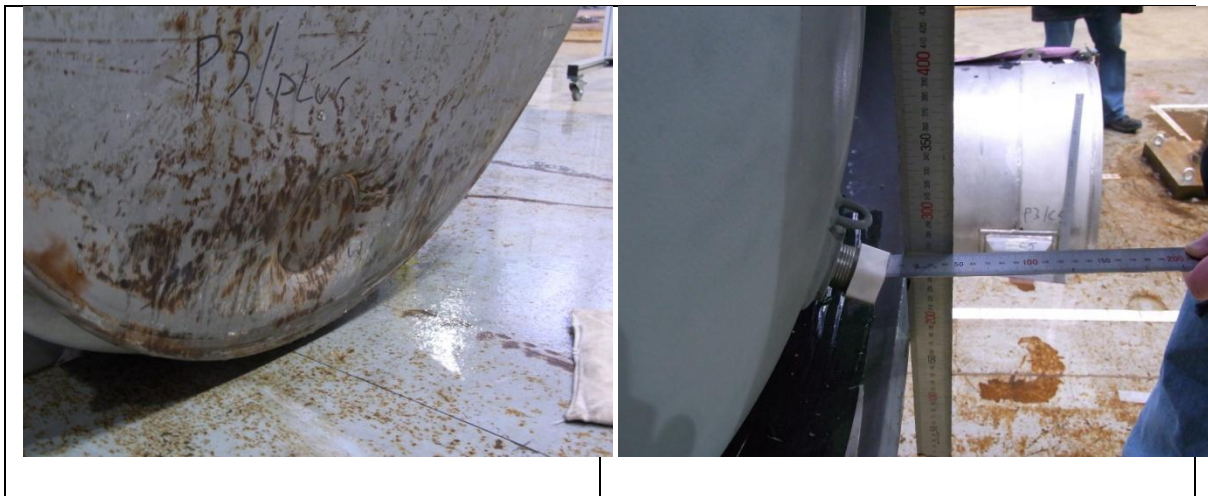
The outer shell was deformed due to the 9 m drop test and 1 m bar drop test. No cracks in the outer shell were detected (see Fig. 11). A small opening between the upper and lower half-shell occurred at the plug side. This opening allowed no direct contact to the inner 30B cylinder.

There was no visual damage of the closure system apart from small distortions of the two closures in the impact zone. No contact between valve/plug and DN 30 PSP was detected (see Fig. 12). The interior of the upper half-shell was locally deformed at the plug related front end by the impact of the 30B cylinder and the puncture test. The 30B cylinder showed no visual damage. The measured leakage rate was acceptable.

Figure 11: Exterior deformation

Figure 12: View of the plug

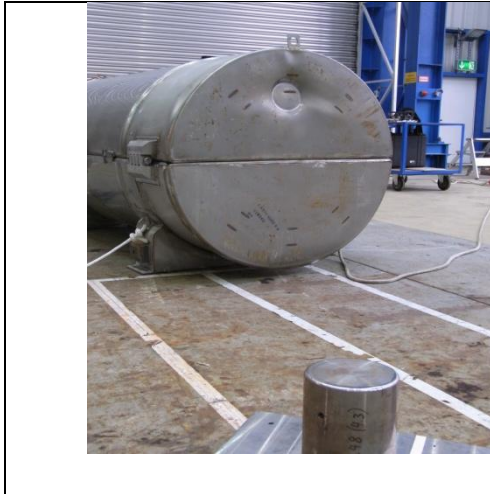
The outer shell showed a relatively small buckling due to the 9 m drop test and a dent due to the bar drop test. No cracks in the outer shell occurred (see Fig. 13). There was no visual damage of the closure system apart from small distortions of the two closures in the impact zone (these two pins had to be removed by hammer). No opening between upper and lower half-shell. No contact between valve/plug and DN 30 PSP was detected.

**Figure 13: Exterior deformation**

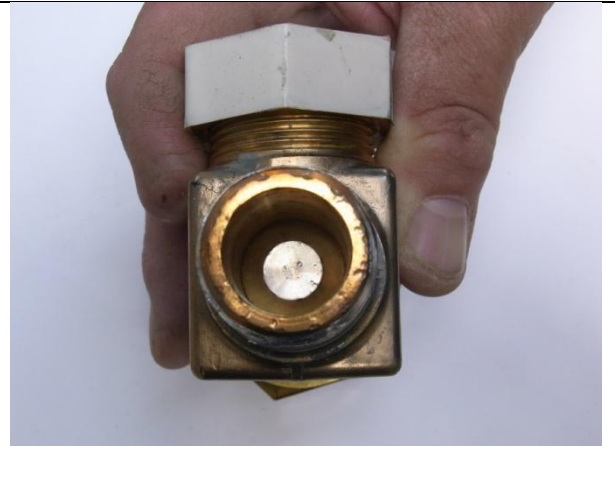
The leakage rate was slightly unacceptable. The location of the leakage was determined by a subsequent bubble test. The indications occurred at the mounting thread and the side port of the valve. By dismounting the valve the loosening torque was measured with 380 Nm. The valve showed imprints of the simulated content (steel balls) on the front end of the spindle (see Fig. 14)

**Figure 14: Valve spindle with imprints**

During the flat vertical drop onto the valve side (sequence 4) and the flat horizontal drop onto the closure line decelerations were measured which were in a range of approx. 800 g. These caused a failure of the valve and unacceptable leakage rate. A comparison of the test results with the earlier finite-element calculations showed that the deformations during the drop tests were much lower than predicted by the calculations resulting in much higher decelerations as expected. The reason for this was that the dynamic compression strength of the foam which was directly injected into the DN30 structure was higher as expected from measurements on sample cubes. The lesson learned was that an adequate quality control of directly injected foam is rather difficult if not impossible. Hence the foam parts are now prefabricated and quality controlled before they are mounted into the DN30 steel structure.

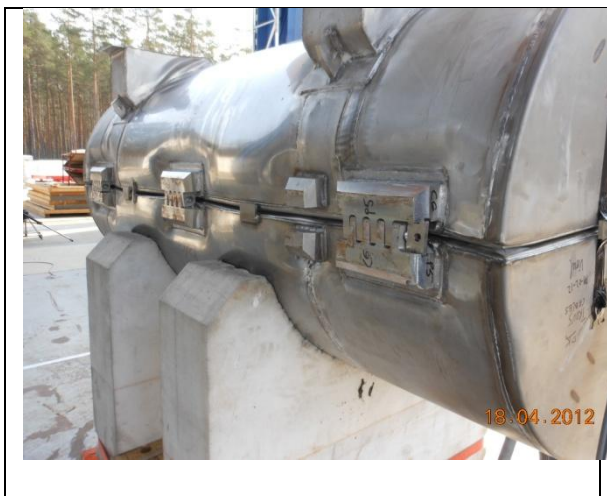
Strong deformations of the upper and lower half-shell in the region of the impacted closures occurred due to the 9 m drop test (see Fig. 15). Additional deformation of the impacted closure were caused by the bar drop test. No cracks in the outer shell were detected.

**Figure 15: Exterior deformation**

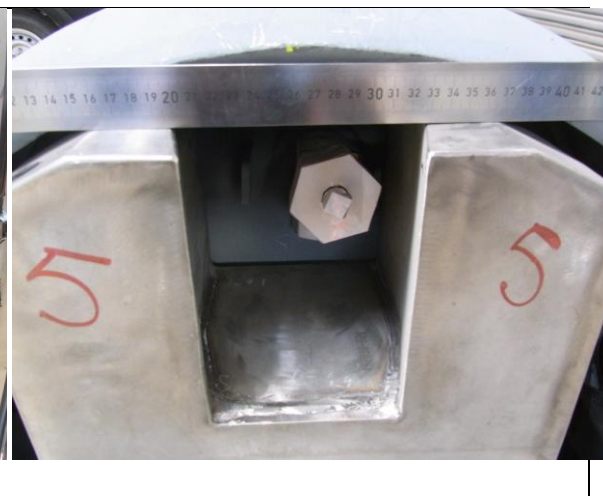
The DN30 PSP remained closed. A small opening was detected between the upper and lower half-shell at the valve related end face. This opening allowed no direct contact to the inner 30B cylinder. No opening at the plug related end face. No contact between valve/plug and DN 30 PSP occurred (see Fig. 16)

The leakage rate was unacceptable. The location of the leakage was determined by a subsequent bubble test. The indications occurred at the valve itself. No bubbles occurred at the mounting thread of the valve.

**Figure 16: View of the valve**
