**Proceedings of the 17th International Symposium on the  
Packaging and Transportation of Radioactive Materials  
PATRAM 2013  
August 18-23, 2013, San Francisco, CA, USA**

**Transport of Dis-assembled Cyclotron**

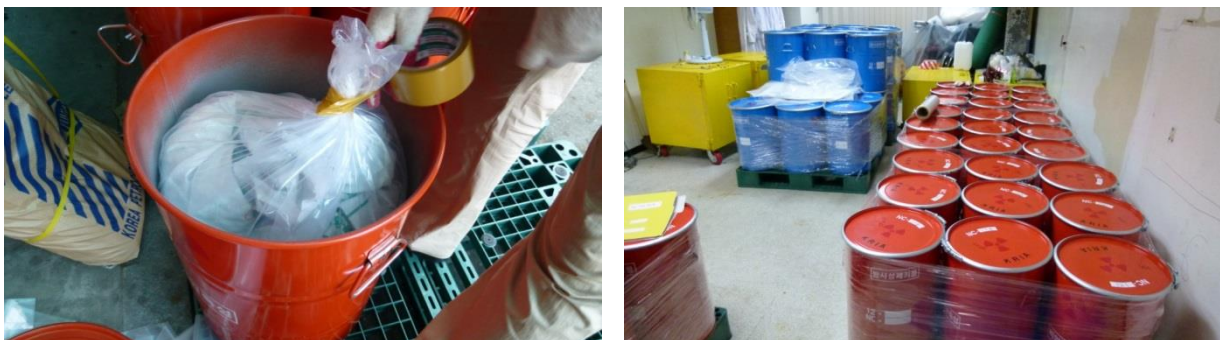
**Figure 3. Transport of some part of steel sand and coolant**

At first SNUH had plans to transport steel sand in shielding beforehand, and they transport it using drums for IP-1 package. But because steel sand was mixed with coolant water, it was difficult to pack a lot of drums. So, they changed the plan to transport shielding components with steel sand. Because the radiation levels were vary and there were some errors in estimation of specific activities, and it was hard to meet the transport regulations for preparing consignments, special arrangement was considered for the safe transportation.

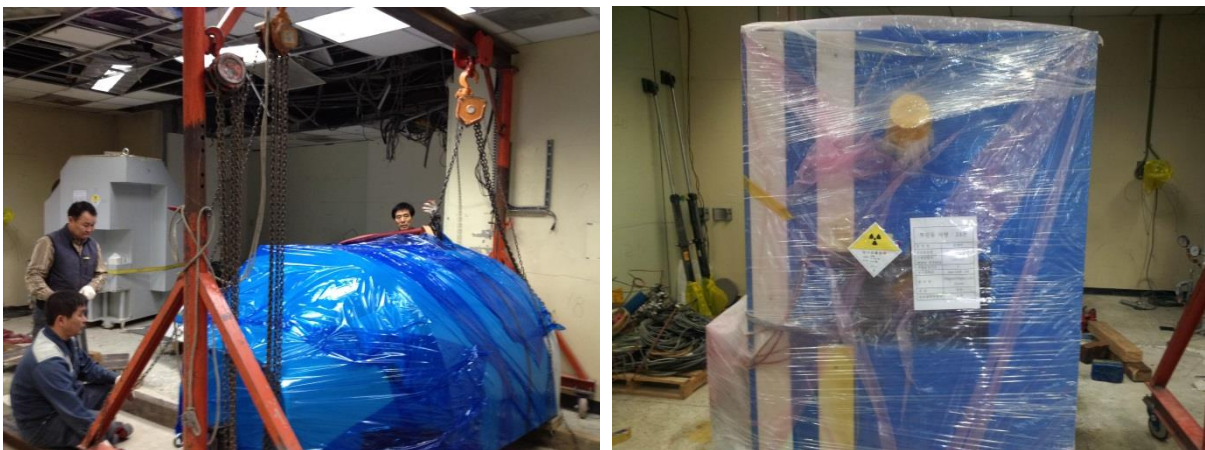
**Figure 4. Dismantling by special working group and preparation for transportation**

The hardest thing was to carry heavy and large objects through the narrow and long hallway of the old building. Around the building where the cyclotron installed, some newer buildings had been constructed. The buildings were connected with long and narrow hallway. The components of the cyclotron should be carried out along the hallway. For dismantlement of cyclotron and carrying its components in the small space, special workers were invited. They had been trained about radiation safety and patched individual dosimeter. Because the place was very crowded hospital, carrying packages had to be done at night time to make easy control public.

Dismantling, packing, carrying and transportation were done in very hard circumstance. Especially dismantling into components which weigh up to 9 metric tons in the small cyclotron vault and carrying through narrow and complex hallway could not help being done by special team. To monitor dose of individuals they monitor the working spaces and applied TLD as dosimeter. Fortunately there were no evidence those workers received radiation dose.
