Paper No.5025

## SCC Tests of the canister for spent nuclear fuel storage using full scale lid model

M. Wataru  
CRIEPI

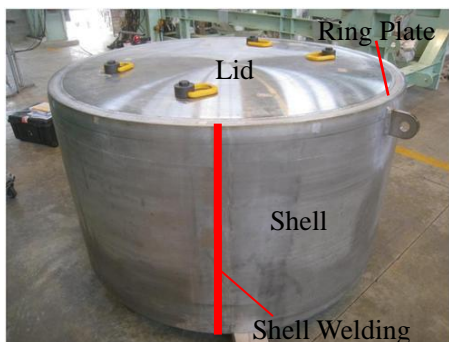
Figure 1 Photographs of Mock-up

A typical canister for storage of spent nuclear fuel is about 1.8m in diameter and about 4.8m in length. To investigate canister SCC, it is important to reproduce the real stress and surface condition of the canister. The mock-up for the experiment is full-scale in diameter but short in length because of the limitation in size of the experiment chamber (Fig.1). Its outer diameter is about 1.832m and height is about 1m (Fig.2). The thickness of the shell is about 16mm. The mock-up is the lid part of the canister. SCC evaluation of the lid part is more complicated because the lid weld is a partial penetration weld. The mock-up is made of stainless steel type 304L. There are several lid designs for a canister. This mock-up used a lid with a ring plate. The ring plate is placed on the edge of the lid. After the lid was welded to the shell, the ring plate was welded to the shell and the lid. When the lid was welded to the shell, the top part of shell inclined to the inside. The shell weld in the axial direction was MIG weld. Firstly, two flat plates were welded. The welded plate was formed into a cylinder. Then, another weld in the axial direction was performed. Excess metal of the shell weld was removed by grinding. For the welding of the shell, Radiographic Testing (RT) and Penetrant Testing (PT) were executed. For the lid and ring plate welding, PT was executed. No flaw indications were observed.

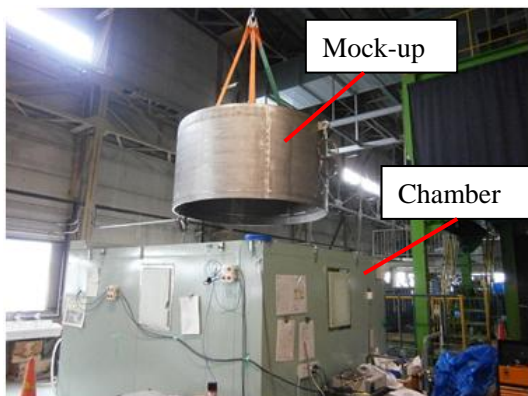
**Figure 5 Handling Process of Mock-up**

To keep the environment conditions constant during experiments, the temperature and humidity chamber was used (Fig.5). The size of the chamber inner cavity is 2.2m in width, 2.65m in depth and 1.8m in height. The ceiling of chamber is removable. When the mock-up is set in the chamber using a crane, the ceiling is removed. The lid of mock-up is face-up in the chamber (Fig.6).

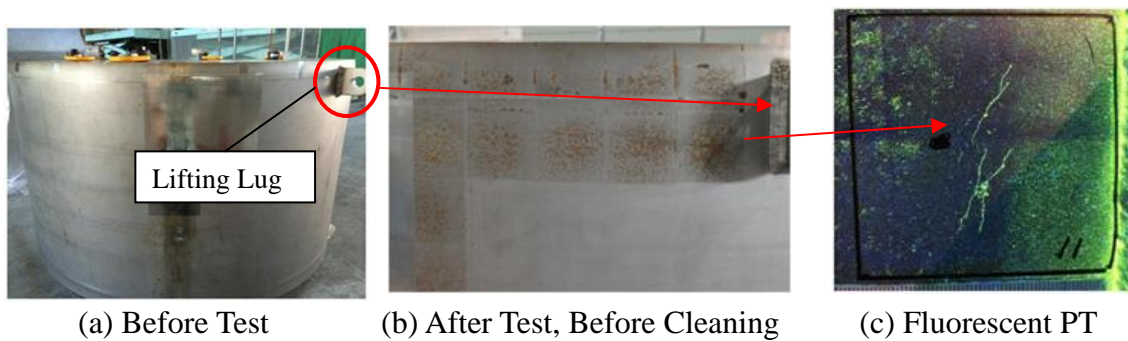
**Figure 11 Results of VT and Fluorescent PT in area near the Lifting Lug**

Furthermore, indications of SCC were observed near the area of the lifting lug (Fig.11). The lifting

lugs are welded only to this mock-up and not the actual canisters. Taking practical handling of the test into account, the lifting lugs were welded. If the temporary lifting lugs are welded during the fabrication process, it is necessary to pay attention to the residual stress after removing the lugs.

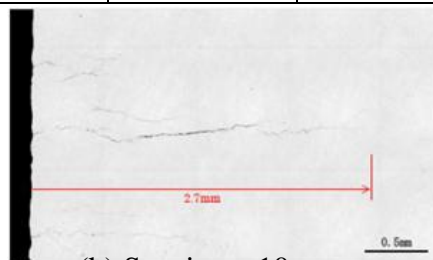
(b) Specimen 10

(c) Specimen 19

(d) Specimen 11

**Figure 13 Photographs of Measurement of Crack Depth**

To determine SCC and measure the crack depth of SCC, the suspicious areas were selected by PT indications and cut into small plates of about 75×75mm in size. Fig.12 shows the positions where the plates were cut. Using these plates, surface cracks and cross-section of the cracks were observed using a microscope. Table 1 shows the measurement results of crack depth. Fig. 13 shows the cross

section of the specimens.

On the LPB treated surface and shell welding area, SCC initiation was not observed. The measured crack depths were less than 4mm except for the area near the lifting lug welding. The results of crack depth were similar with four-point bend test results and SCC test of the bottom part mock-up [11]. The measured crack depth near the lug was about 7 mm.
