Paper 1132

**Study of the occurrence of hidden corrosion in packaging steels, exposed to potentially corrosive materials such as resin, compound, or foam, in transport conservative temperature/humidity conditions**

**Claude LEROY, Sébastien  
CLAVERIE-FORGUES**  
CEA Cadarache FRANCE

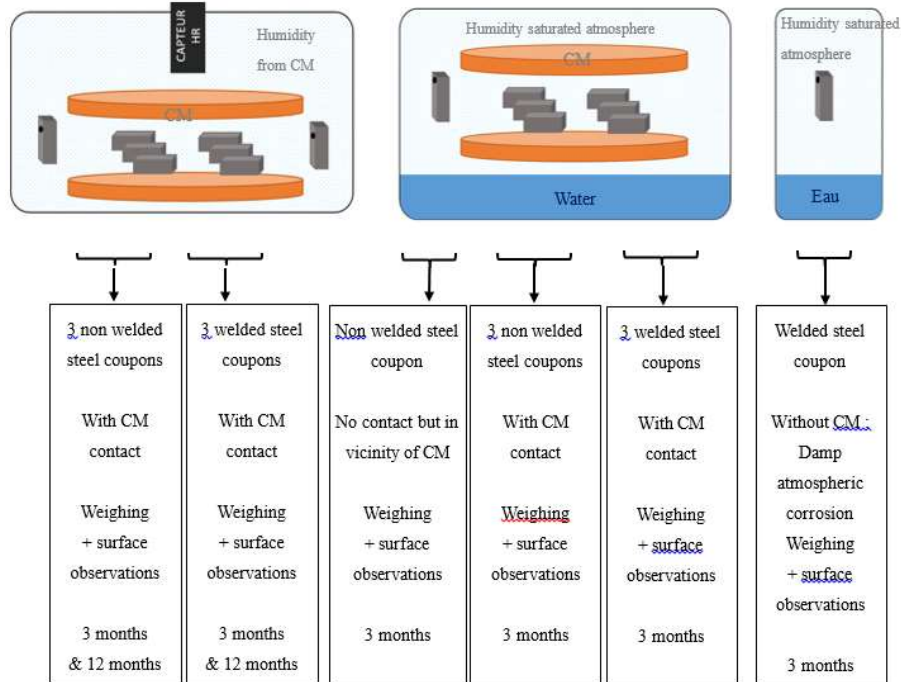
Figure 1 : Program outline

This program is summed up in figure 1.

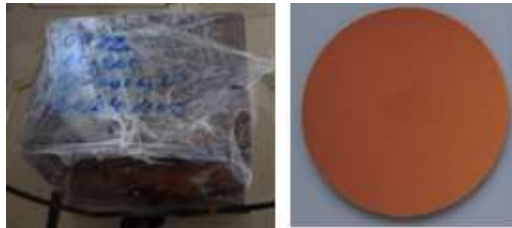
**Figure 3 : 200h phenolic foam**

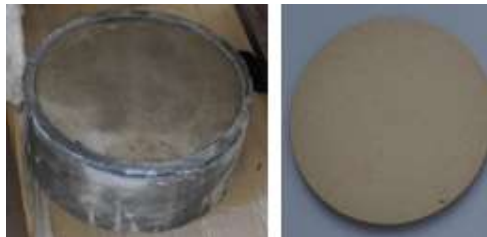
**Figure 4 : borated mortar-type PNT 7 compound**

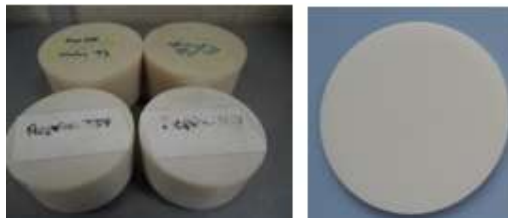
**Figure 5 : HETRON resin**

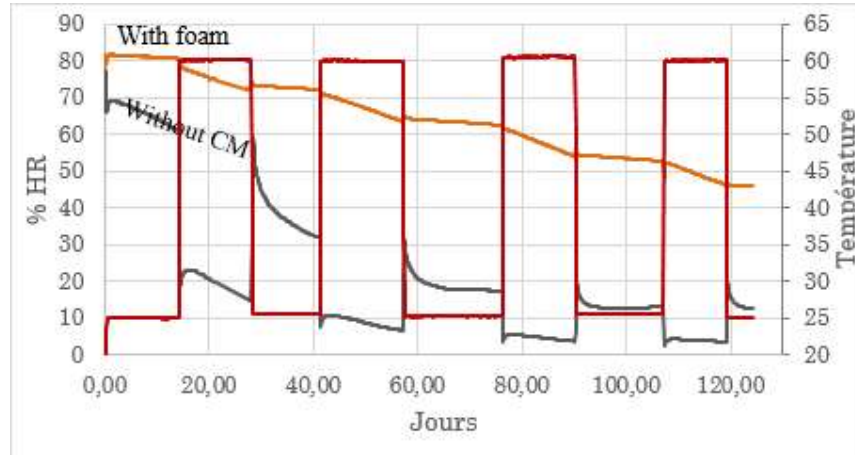
**Figure 8 : Relative humidity evolution in an empty cell and a cell with 200H foam**

The model reference is ROTRONIC HC-2S up to 85°C and HC-2 IC102 up to 160°C. It is connected to a PC for continuous recording. The sensor was tested in an empty cell and a cell with 200h foam with 25°C/60°C cycles before the official trial and it shows the capacity of the foam to release humidity gradually, and the fact that there is a loss of humidity due to an insufficient leak-tightness level of the reactor at high temperature (see the slow downward curves in fig.8 each time the cycle temperature is high). This is the reason why 3 months trial with permanent 100% humidity were added to the program.
