CNSC's Regulatory Efforts for Improvement in Response to Transport Events

Rajesh Garg, Canadian Nuclear Safety Commission, Ottawa, Canada
Lacey Wallace, Canadian Nuclear Safety Commission, Ottawa, Canada

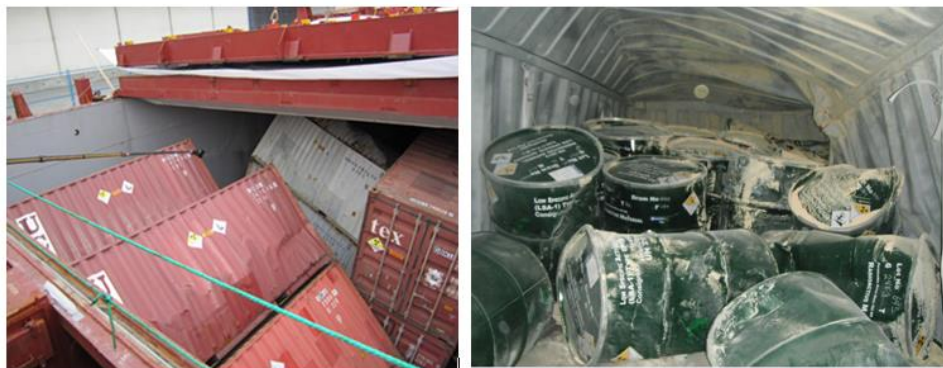
On January 4, 2011, Cameco notified the CNSC that a sea shipment containing natural uranium concentrate, also known as yellowcake, en route from Canada to China had encountered extremely rough seas in the Pacific Ocean and that there was the potential for damage of the packages containing the uranium concentrate, which were packaged inside sea containers. The vessel, MCP Altona, returned to Canada on January 15, 2011.

Shifted cargo carrying yellowcake during rough sea conditions aboard Marine vessel MCP Altona in Vancouver

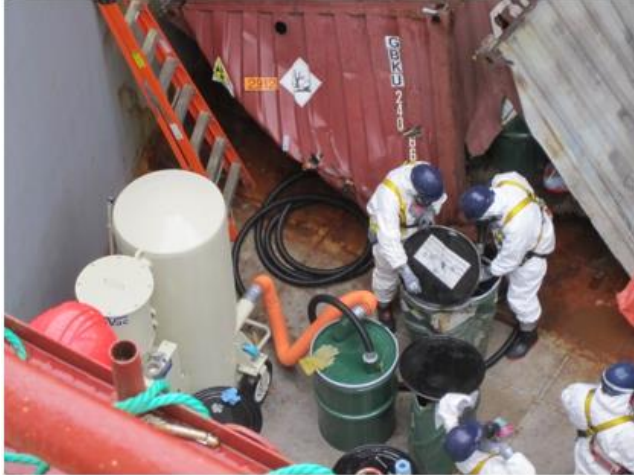
Recovery – Cleanup of cargo hold

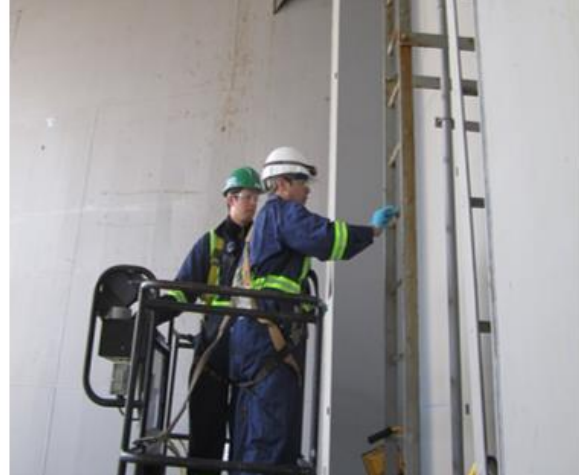
CNSC Inspector verifying cargo hold

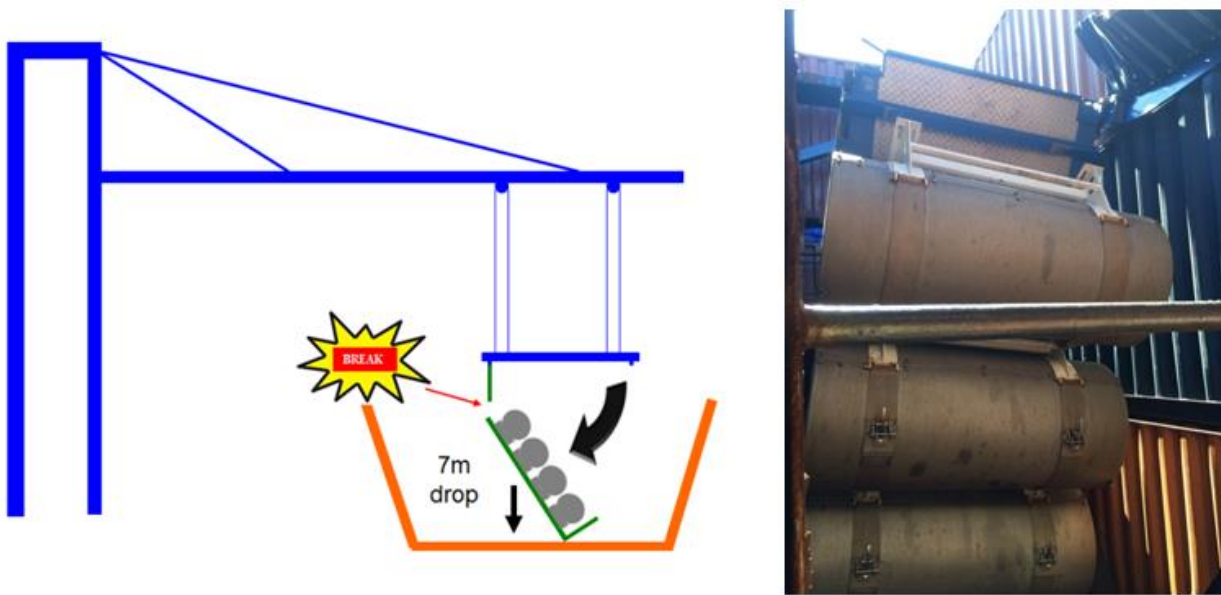
From the consignor's report, one side of the flatrack was not properly secured to the crane. This resulted in all the weight (18,000 kg) being supported by only one side of the flat rack. The unsecured side moved downward in a pendulum motion towards vertical position and caused it to shear off from the flat rack base.

UF6 package dropped while unloading in Halifax

On March 25, the packages involved in the event were opened. A visual examination of each cylinder was performed. The cylinders were declared free of damage and were transferred inside new overpacks.

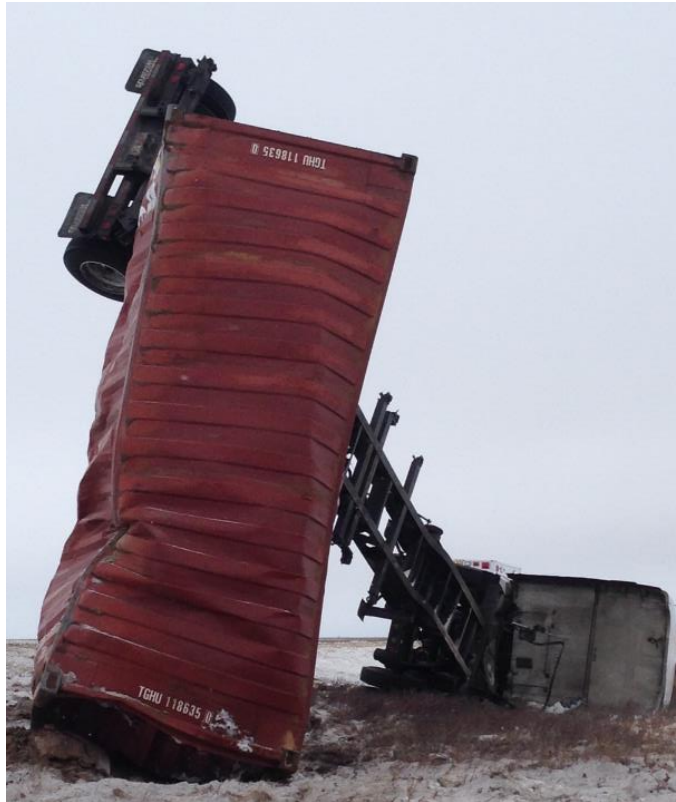
On January 11, 2016, Cameco reported to the CNSC that a truck transporting a sea container loaded with uranium concentrate drums was involved in a single vehicle traffic accident near Swift Current, SK, about 270 km from Saskatoon. The shipment consisted of 63 steel drums, each containing natural uranium concentrate, in powdered form and stacked two rows high within a 20-foot ISO freight container loaded onto a trailer. The truck and trailer carrying the sea container rolled over on its side, the container became detached from the trailer with severe damage, and it appeared to be breached with some evidence that a small amount of yellowcake had spilled on the ground. The highway was closed to traffic in both directions for 1 km. The driver of the vehicle suffered minor injuries.

Rolled over truck carrying yellowcake near Swift Current

In response, Cameco communicated with the local emergency response personnel department, activated their ERAP and dispatched a Cameco team from their corporate offices in Saskatoon. It was determined that there was a small amount of contamination on the exterior of the container. The contamination was cleaned up and the container was sealed with expanding foam to ensure there would be no more escape of radioactive material. The damaged container was placed into an oversized container and transported to Cameco's Saskatoon facility.

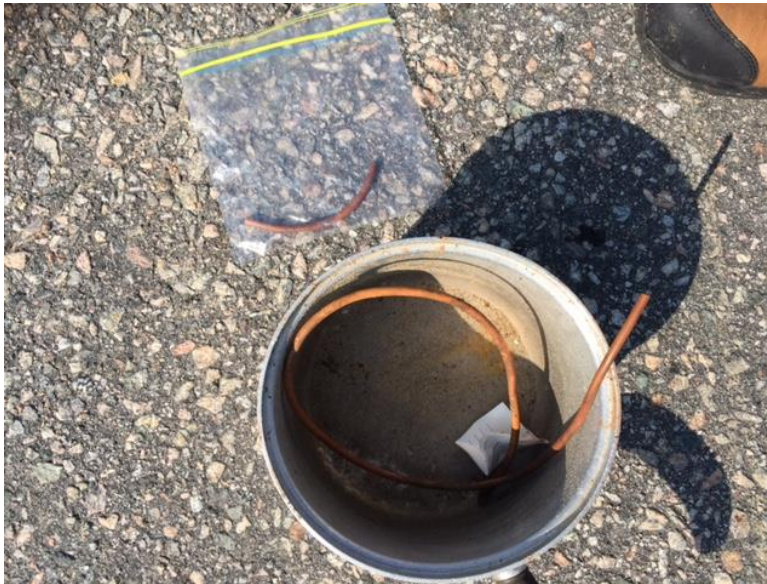
A hired consultant identified the source of radiation to be from a cable used in an old jet from the Second World War. The consultant proceeded with the proper disposal of the cable.

Contaminated cable found in the North Bay event
