Paper No. 1300

5-Year Accelerated Corrosion Testing of MAXUS® for Spent Fuel Pool and Dry Cask Performance

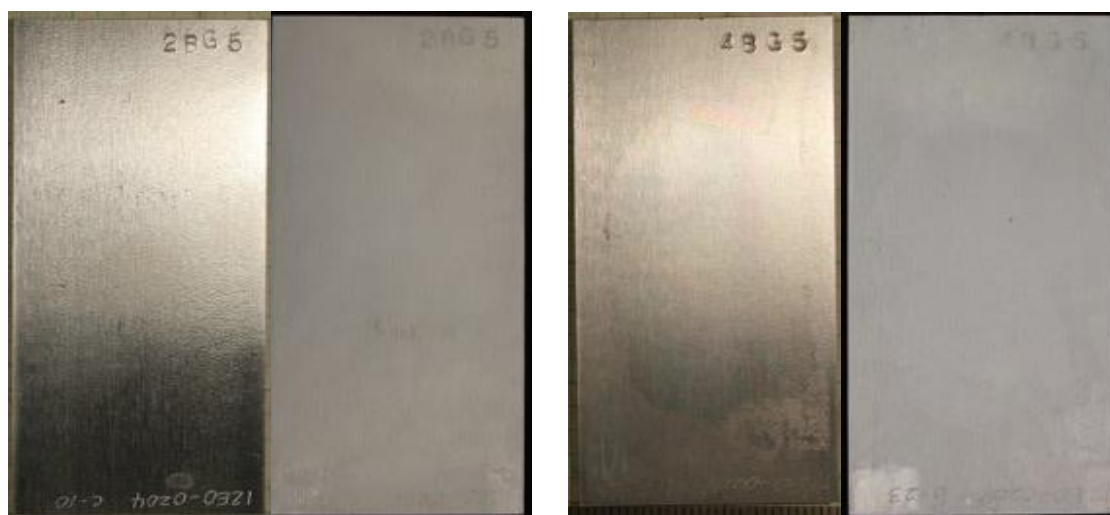
Figure 3 MAXUS[®] 5-Year BWR Bath General Coupons

21wt% B₄C BWR General

40wt% B₄C BWR General

The pre-characterized coupon photos are to the left of the as-tested coupons. Note that there are stains associated with the coupon holder rack on the bottom corners. Other than that, there is very little change from the pre-characterized state.

All coupons were subjected to measurement and visual inspection upon removal from the test baths. High resolution photographs were taken of all coupons upon removal. The length, width, thickness, density and dry weight of the flat 5-year test coupons were compared to the pre-characterization values. No discernable changes were noted. No blistering or delamination of the flat coupons was observed in any of the test coupons. This was expected due to the near full density of the MAXUS[®] material and the absence of any porosity. None of the coupons exhibited signs of significant general corrosion, but some exhibited evidence of localized corrosion or pitting. The degree of pitting observed was dependent on the coupon test configuration and bath. Encapsulated coupons that were placed in the PWR test bath had greater pitting than the other coupons. Figure 3 compares the surface condition of the BWR general coupons to their pre-characterized state.

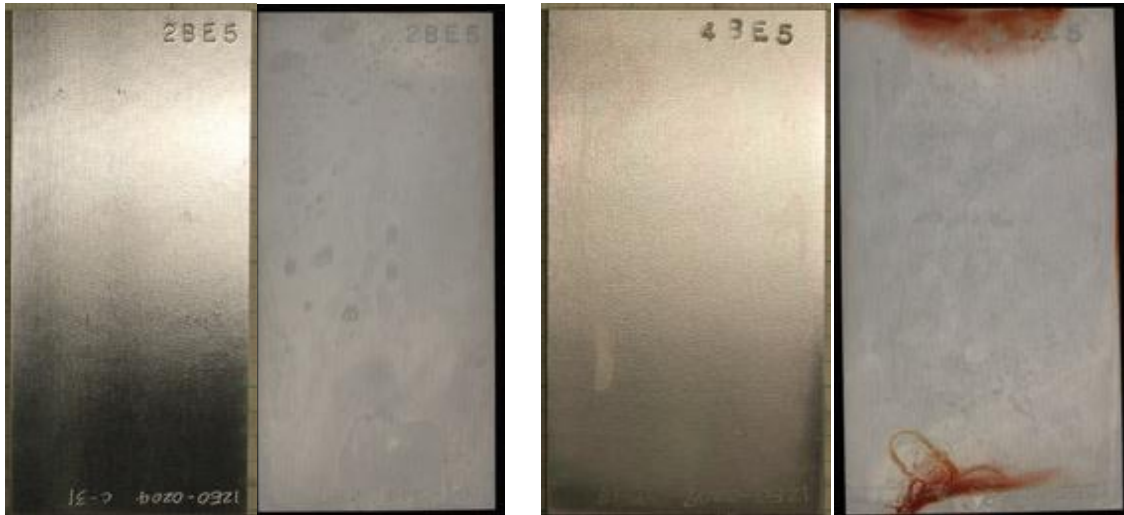
Figure 4 MAXUS® 5-Year BWR Bath Encapsulated Coupons

The BWR encapsulated coupons have two features that are different from the pre-characterized state. There was iron oxide discoloration at the location of the capsule vents of the 40wt% B₄C coupon. Also, there was some surface pitting near the capsule vent locations of both coupons. Figure 4 illustrates the condition of the BWR encapsulated coupons. As for Figure 3, the pre-characterized coupon photos are to the left of the as-tested coupon photos.

21wt% B₄C BWR Encapsulated

40wt% B₄C BWR Encapsulated

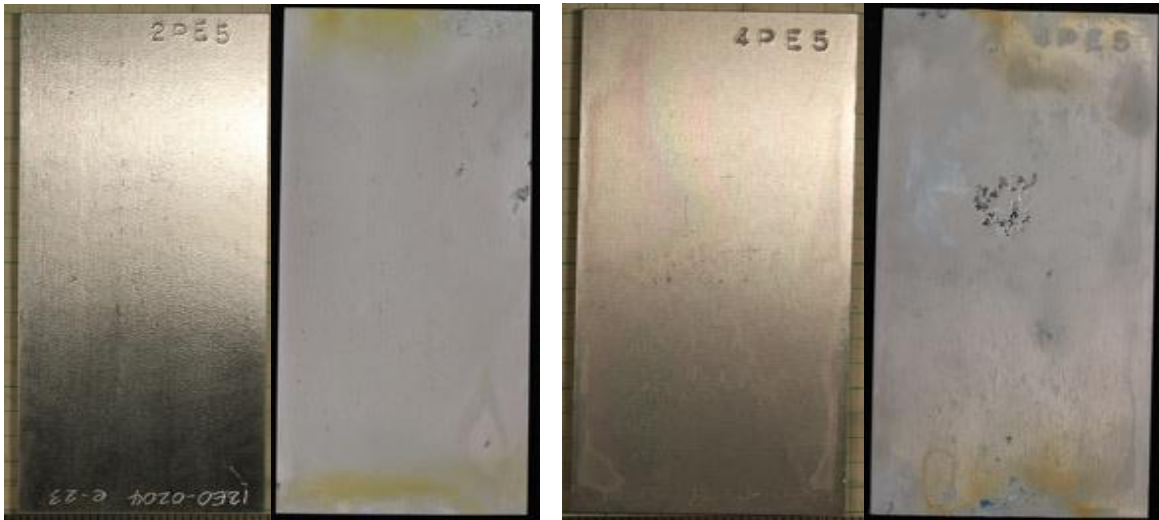
Figure 6 MAXUS® 5-Year PWR Bath Encapsulated Coupons

The as-tested condition of the PWR encapsulated coupons have similar features to that of the as-tested BWR encapsulated coupons. There is rust staining of the coupon near the capsule vents and there are indications of pitting. The pitting of the encapsulated PWR coupons appears to be more developed than that of the BWR coupons. Figure 6 illustrates the condition of the PWR encapsulated coupons. As previously, the pre-characterized coupon photos are to the left of the as-tested photos.

21wt% B₄C PWR Encapsulated Coupons

40wt% B₄C PWR Encapsulated Coupons

Localized corrosion was observed on many of the flat test coupons. The pitting occurred in small pockets where the local chemistry becomes ideal. In higher areas of water flow such as exposure to the open circulation within the test bath that the general coupons experience, the local surface conditions are not amenable to pitting. However, in localized stagnation points or areas of low water flow, pitting was observed to be more prevalent. These pits appear to be the result of crevice geometry and thus more present in the encapsulated coupons as compared to the general coupons. This effect is further enhanced in the lower pH environment of the PWR test bath.

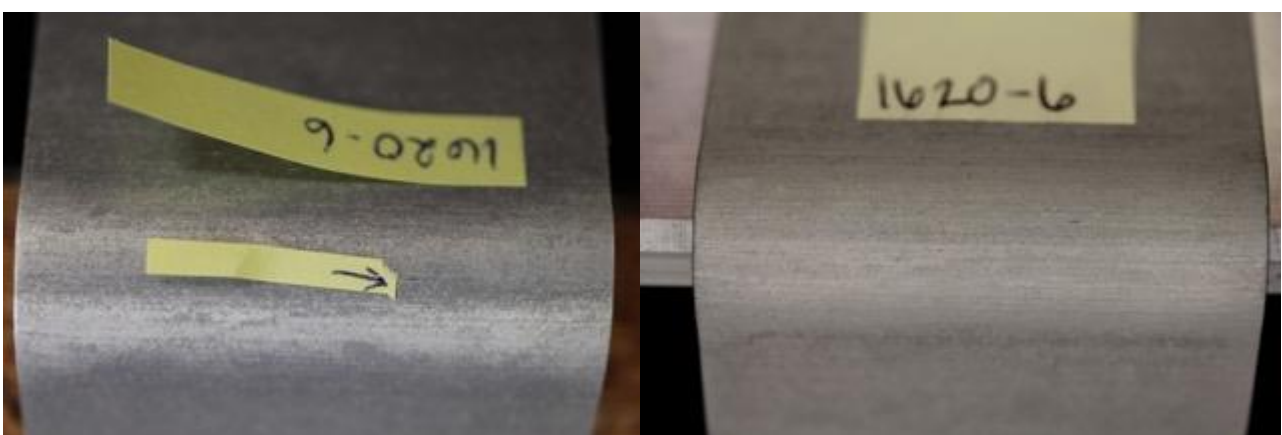
Figure 8 MAXUS® 12-month, BWR Bath Bend Coupon

can be observed on the edges of the coupon. Otherwise, no significant change features can be noted. Figure 8 compares the pre-characterized bend coupon 14E0-1620-6 (30wt% B₄C) to the coupon after 12-month immersion in the BWR bath. Aside from the slightly different photo lighting, there is no discernible difference between the pre-characterized and post-immersion coupon surface conditions as noted in the photos. As with the PWR bend coupon comparison, the pre-characterized coupon is on the left.

BWR Bath, 12 month, 30wt% B₄C

No significant indication of general corrosion was noted in the bend coupons either through the visual examination or by comparison of pre-characterized and post-immersion coupon weight. Examples of bend coupon visual examinations are provided in Figures 7 and 8. Table 7 illustrates the measured changes in bend coupon weight and effective corrosion rate per year consistent with that reported for flat coupons. The maximum weight gain was 0.03% and the maximum weight loss was 0.13%. There is no indication of corrosion impact to the cold worked bend coupons.
