## EXTENSION OF CONTAINER LIFE THROUGH LOW-COST PROBABILISTIC ASSESSMENT

**Tim Gleed-Owen**  
**(Senior Engineer, RAM Containers)**  
Rolls-Royce Power Engineering Plc, PO Box 2000,  
Derby, DE21 7XX, Great Britain

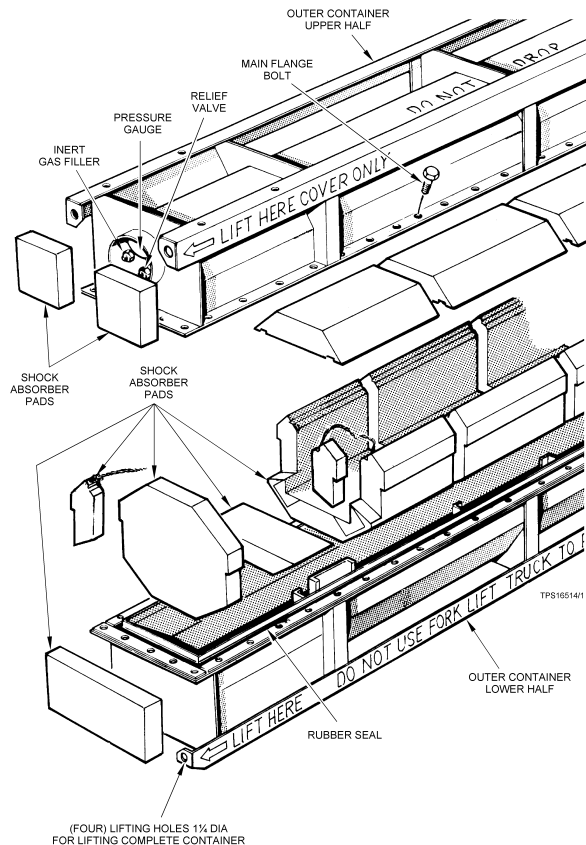
**Figure 1 Exploded View of New Fuel Assembly Shipping Package**

The outer container design is of a long rectangular-profile box, constructed of low-alloy steels and painted inside and out for corrosion protection. Along the horizontal centre-line is a flanged joint that allows the upper half, and its shock-absorbing features, to be lifted away for access to the inner container that carries the fuel assembly. A part view of the outer container is shown as Figure 1, the inner container omitted for clarity. The lower flange has clearance holes for the bolts and 5/8-11 UNC hexagon full-nuts welded to its lower surface. These nuts are attached by continuous fillet welds along the five accessible edges of the hexagonal nut, and were renewed at major overhaul thirteen years prior to this. Material for the nuts is a carbon steel, and because of the risk of corrosion of these female threads, a legacy instruction for each turnaround maintenance had been to pass a thread-cutting tap several times through each nut to clear out any loose debris or corrosion. Main flange bolting uses carbon steel hex-head bolts, with nickel-plated threads to negate the need for lubrication on assembly.
