## Demonstration of Impact Performance of the Nuclear Transport Package in On-Site Hypothetical Collision Scenarios by a Heavy Goods Vehicle

Chi-Fung Tso, Arup, UK  
Conrad Izatt, Arup, UK

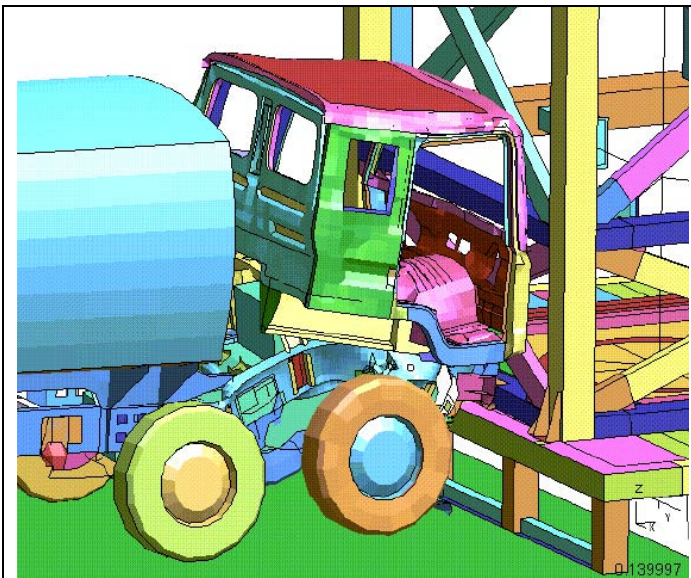
Figure 10: Deformation of HGV and NTP

Deformation of the HGV and the NTP at the end of the event is illustrated in Figure 10.

There were four main load paths in this scenario. The first load path was between the channel section of the HGV chassis and the lower horizontal frame member. This resulted in significant buckling of the HGV's channels, causing the vehicle cab to ride up onto the LLTT chassis. And as significant amount of the HGV's momentum
