6018 Integrity of 30B cylinder plug for physical contact

Mitsubishi Nuclear Fuel Co., Ltd.

Mitsubishi Heavy Industries, Ltd.

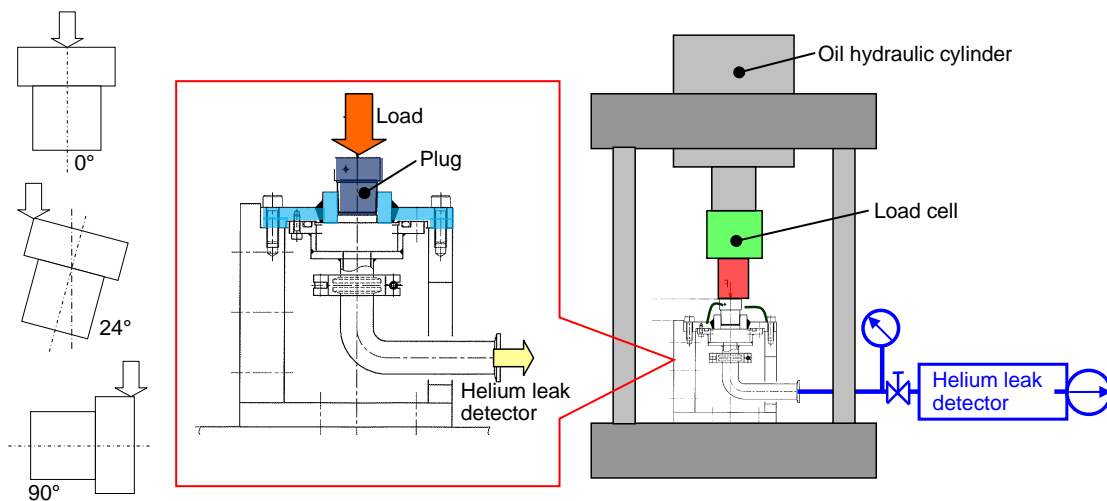
Figure 3. Outline diagram of the test equipment

An outline diagram of the test equipment used in this test is shown in Figure 3. A load is imposed on the plug of the test specimen with a pressing machine through a load cell, and an amount of leak from the plug is measured with a helium leak detector.

This test was carried out for three angles; axial direction (0°), inclination direction (24°) and lateral direction (90°) of the plug. The angle of 24 degrees is the same as the angle that a plug is installed in 30B cylinder. (See Figure 1)

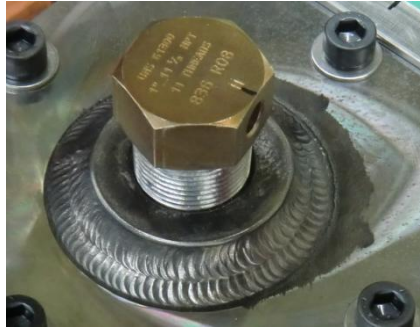
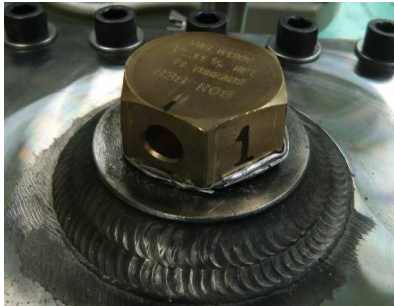
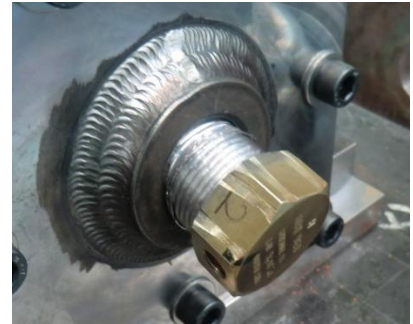
Figure 5. Failed plug after compression test

before test (Case 1-1)

Axial direction load (0°)

Inclination direction load (24°)

Lateral direction load (90°)

In case 1 (compression test in the axial direction of the plug (0°)), the test was conducted using two specimens. In both specimens, the integrity of the plugs was maintained until 350kN of the load. When the load was increased to 360kN, shear fracture occurred at the threads of the plug. However, the leakage rate of the plug has been maintained less than $1 \times 10^{-9} \text{ Pa} \cdot \text{m}^3/\text{sec SLR}$ even after the plug threads failed. The pictures of the plug after the plug threads failed are shown in Figure 5. The cross section which was cut after the test was shown in Figure 6.

In case 2 (compression test in 24° direction against the axial direction of the plug), the test was conducted using one specimen. The integrity of the plug was maintained until 300 kN of the load. When the load of 310kN was applied, shear fracture occurred at the threads of the plug. The leakage rate of the plug was maintained less than $1 \times 10^{-9} \text{ Pa} \cdot \text{m}^3/\text{sec SLR}$ before plug threads failed. After the plug threads failed, the leak rate of the plug slightly increased, but it was about $1 \times 10^{-7} \text{ Pa} \cdot \text{m}^3/\text{sec SLR}$. The pictures of the plug after the plug threads failed are shown in Figure 5. The cross section is shown in Figure 7.

In case 3 (compression test in lateral direction of the plug (90°)), the test was conducted using one specimen. The leakage rate of the plug was maintained less than $1 \times 10^{-9} \text{ Pa} \cdot \text{m}^3/\text{sec SLR}$ until 110 kN of the load. The leakage rate started increasing at 120 kN, and when the load was increased to 125 kN, shear fracture occurred at the threads of the plug. The leakage rate after the plug failed was over $3.7 \times 10^{-4} \text{ Pa} \cdot \text{m}^3/\text{sec SLR}$. The pictures of the plug after the plug threads failed are shown in Figure 5.

In the case of load in 0° and 24° directions, the leakage rate of the plug was maintained at about 1×10^{-7} Pa·m³/sec or less after the plug threads failed. As shown in Figure 5, the plug threads fractured in the shape that they were pressed into the coupling. In this type of fracture, containment ability of the plug could be maintained due to the solder on plug threads gets through the gap between the plug and the coupling.

On the other hand, in the case of the load in 90° direction, the plug was not pressed into the coupling. The plug failed by pull out force due to moment as shown in Figure 5.

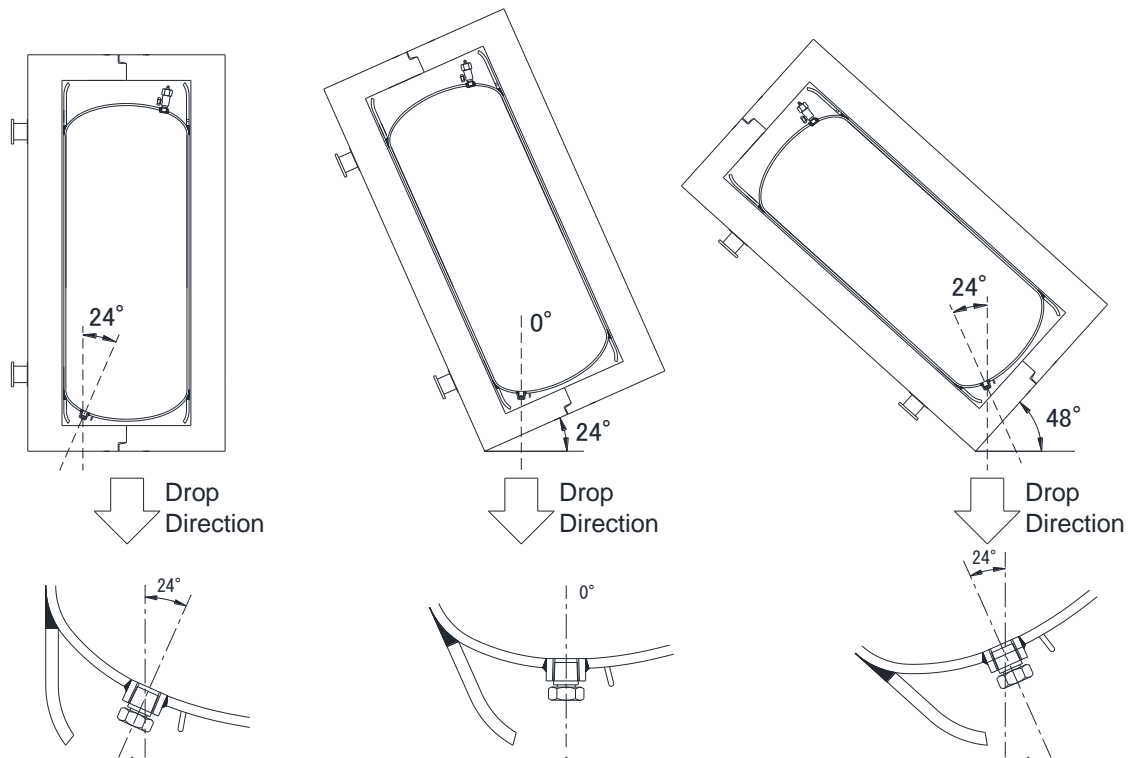
Figure 9. Relation between Plug Angle and Drop Direction

In the case of the load in 0° and 24° directions, the test result shows integrity of the plug can be maintained for the load up to about 300 kN. Here, assuming that the direction of load acting on the plug due to contact is the same as drop direction simply, this test result means containment integrity of the plug is maintained in drop orientations from vertical (0°) to 48° of angle including corner drop, even if the load up to 300 kN acts on the plug.
